# **PRESSURISED INSEAM BOREHOLES**

Garry Horne, United Mine Workers District Check Inspector

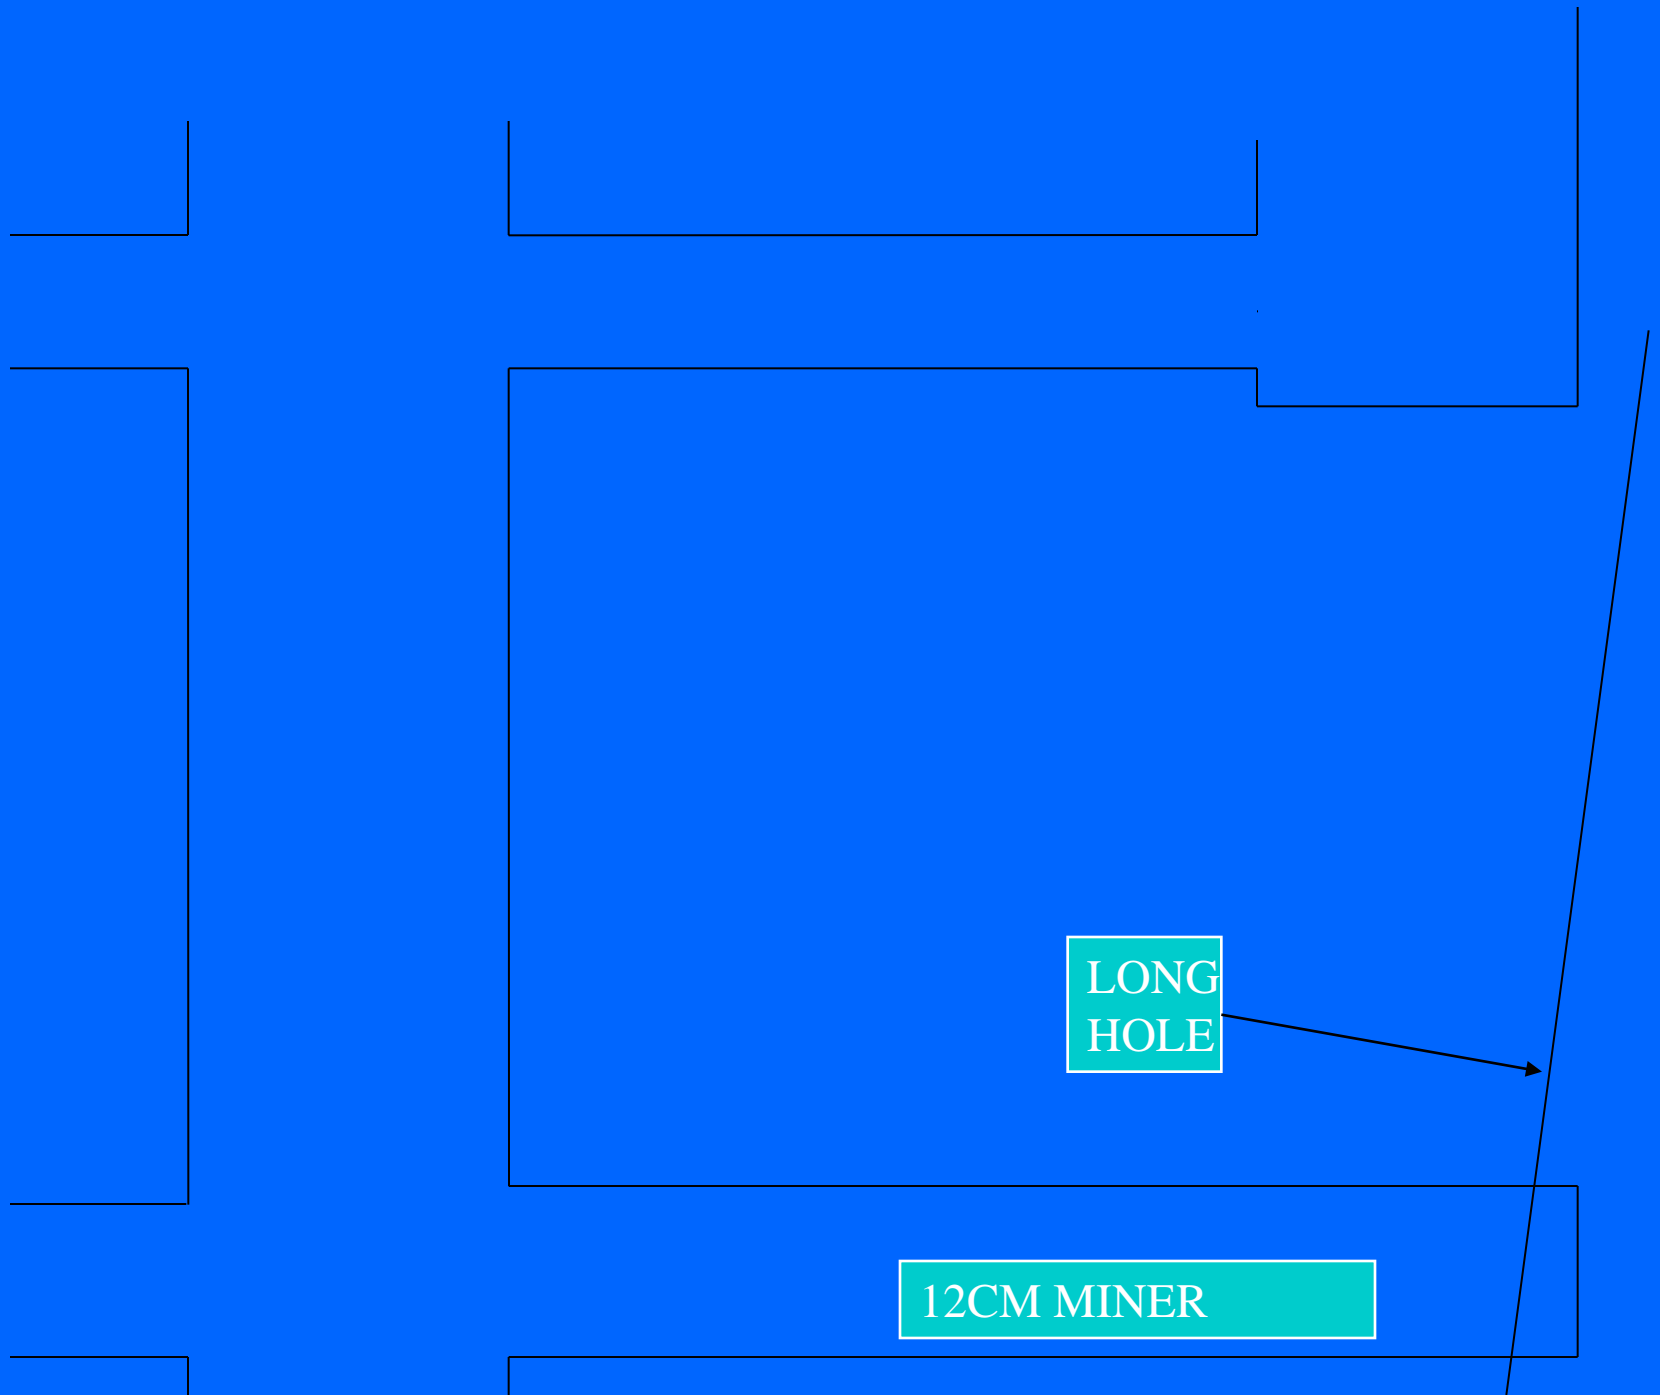
## Appin 1997

My First Involvement With Pressurised Boreholes Was at Appin As L.C.I in 97 When a 12 CM Miner Intersected a Pressurised Borehole.

This Borehole Was Designed to Be a Panel Flanking Hole, but Thru Error Was Over 5 Metres Closer to the Panel Than Planned, It Was Intersected While Driving a Cut - Thru.

Approximately Two Weeks Before the Incident This Hole Had Been Recorded As Giving a Flow Rate of 70 Litres Per Second, This Hole Had Been Turned off After This Reading Without Authority. Long Holes Can Be One Metre off Line Per 100 Metres of Length.

It Was Estimated Thru Monitoring Taken in the Panel Returns That This Hole Liberated 1,000 Litres of CH<sub>4</sub> Per Second.

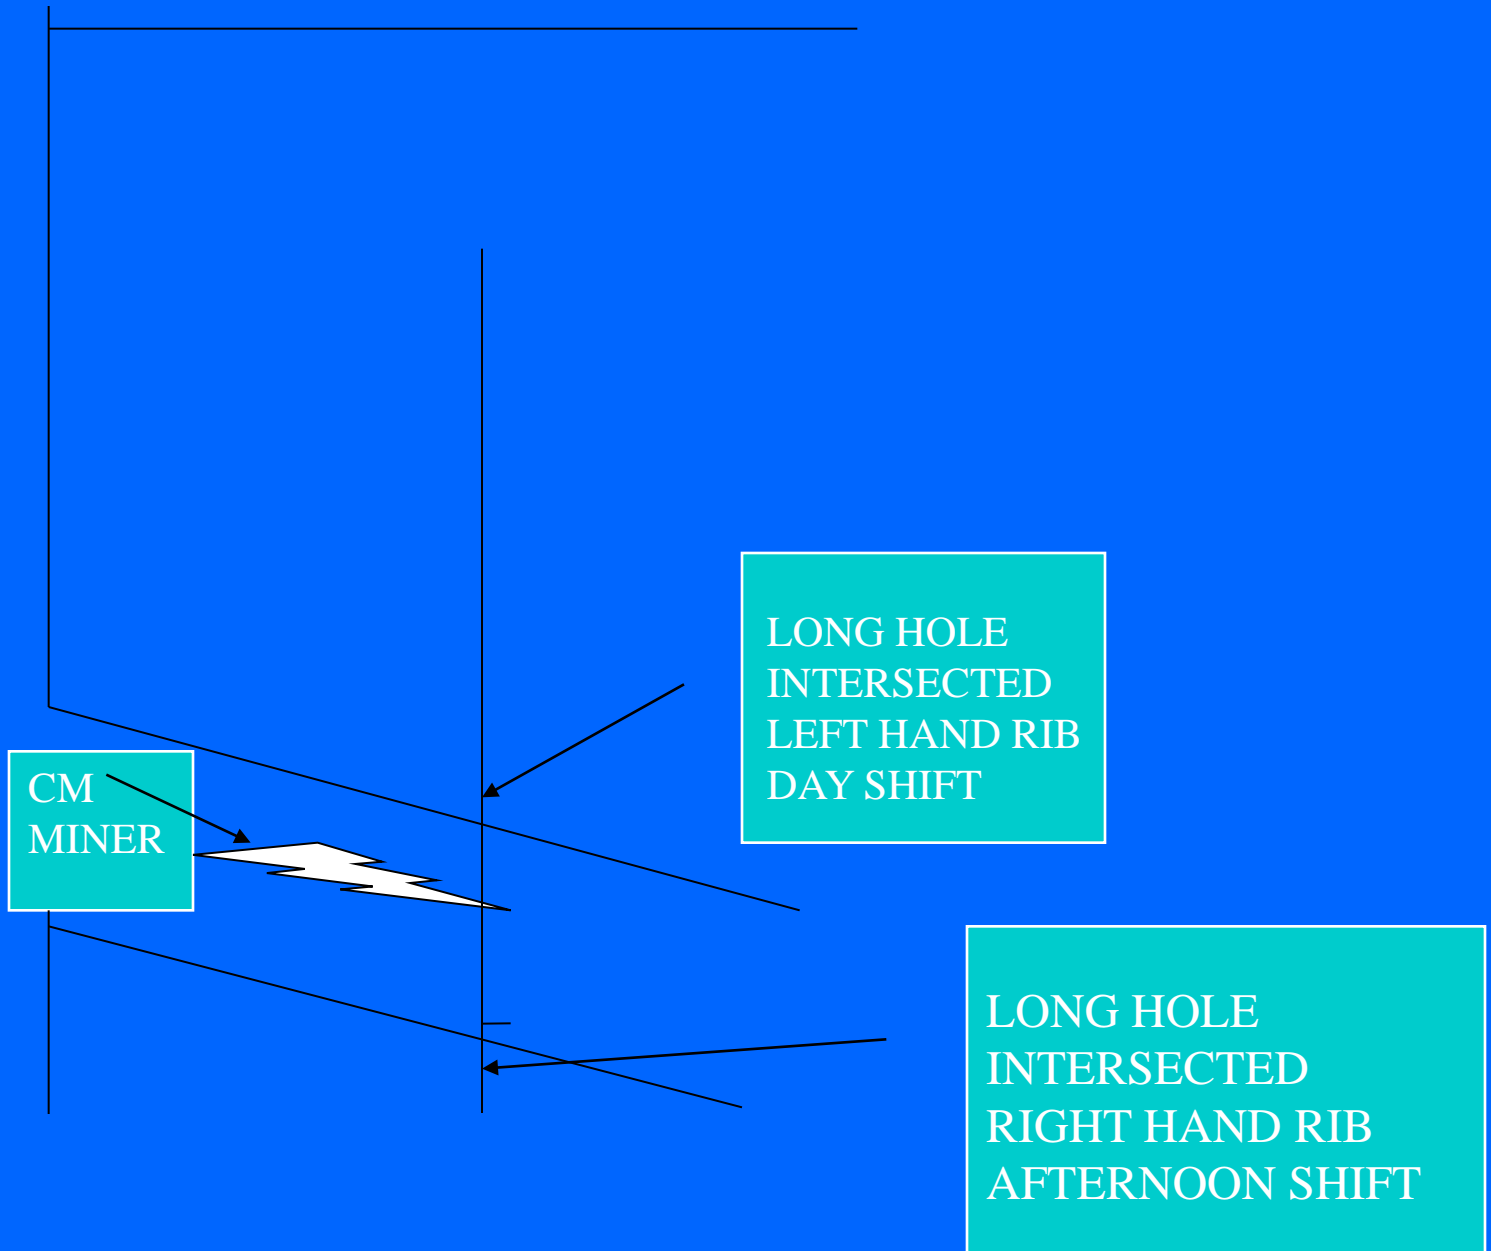
## **Intersection of Surface to Inseam Borehole**

The Hole Was Intersected Day Shift in the Left Hand Rib Driving From B to A in 18 Cut Thru, This Was Noted in the Panel Deputies Report, Maximum of 0.5% G.B CH<sub>4</sub> Detected During the Shift.

The Hole Was Intersected on Afternoon Shift in the Right Hand Rib (Grouted Hole Surface to Seam), It Was Not Making Much Gas. The Crew Was Sent to Crib While a Drainage Line Was Extended to the Face to Place the Holes on Suction.

The Panel Deputy Was Standing on the Miner When the Hole on the Right Hand Side Erupted Issuing Huge Amounts of CH<sub>4</sub>, > 5% CH<sub>4</sub> G.B at the Face, 4.5% in 17 C/t (Panel Deputies' Report).

The Hole Also Ejected Water & Solid Material of Considerable Size Under Great Pressure.

The Deputy Was Sprayed With Material; It Was the Consensus of All Concerned in the Investigation That If the Deputy Had Been in the Direct Firing Line That This Incident Could Have Been a Fatality.

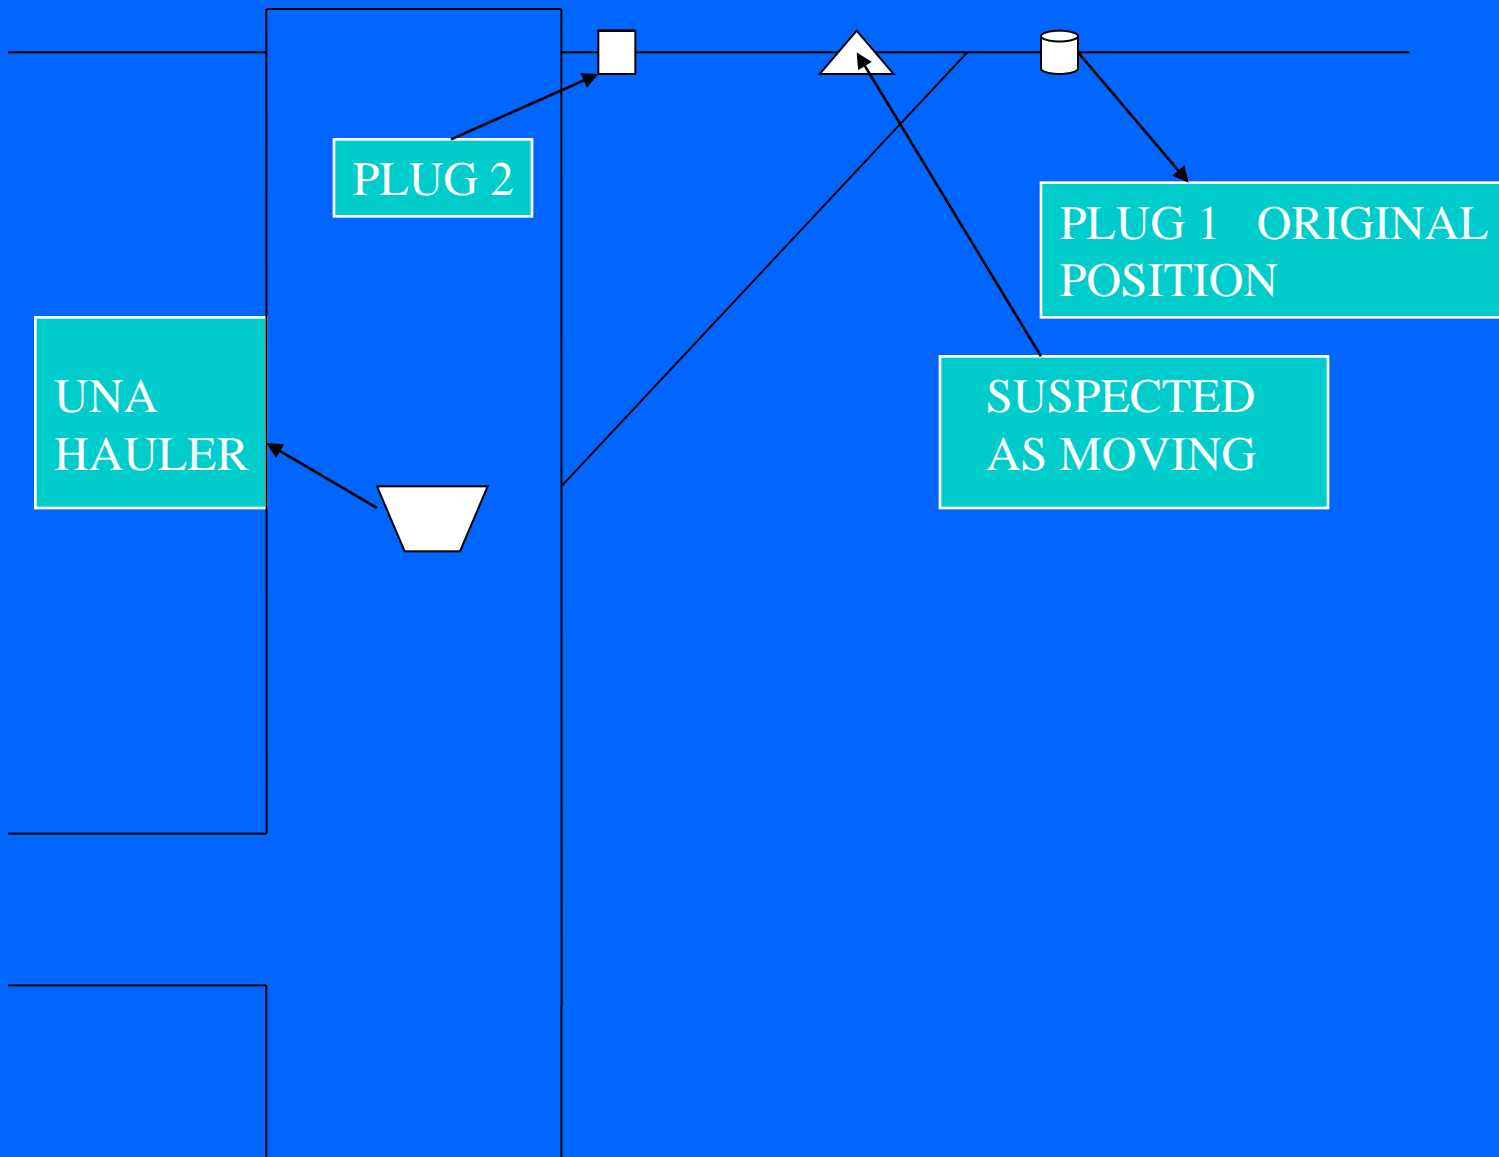
## 802 panel 4.5.04

\*A drainage hole in the right hand rib at the face of B heading, inbye 15 c/t was sealed after being exposed during grunching. After a period of time a drainage hole between this hole & 15 c/t which had been hosed into the return blew out, releasing gas & material under pressure, this led to withdrawal of workers from the area.

- \*A Una – hauler parked opposite the blown out hole was covered in coal & fines as a result of the blowout.
- \*Considerable gas was issuing from the hole at the time of the inspection; the following day after the event.

\*The Hole Plugged at the Face in “B” Heading Had Been Previously Intersected in “A” Heading.

A Plug Had Been Pushed up This Hole From “A” Heading to Approximately 30 metres Into the Virgin Side of “B” Heading & on the Virgin Side of Holes Flanking “B” Heading.

It Would Appear Pressure Built up on This Plug, Moving It & Releasing Gas Out of the Flanking Hole, Which Had Intersected the longhole.
