901TG COAL BURST

25 NOVEMBER 2015

APPIN COMPLEX

901TG PANEL FACE AREA

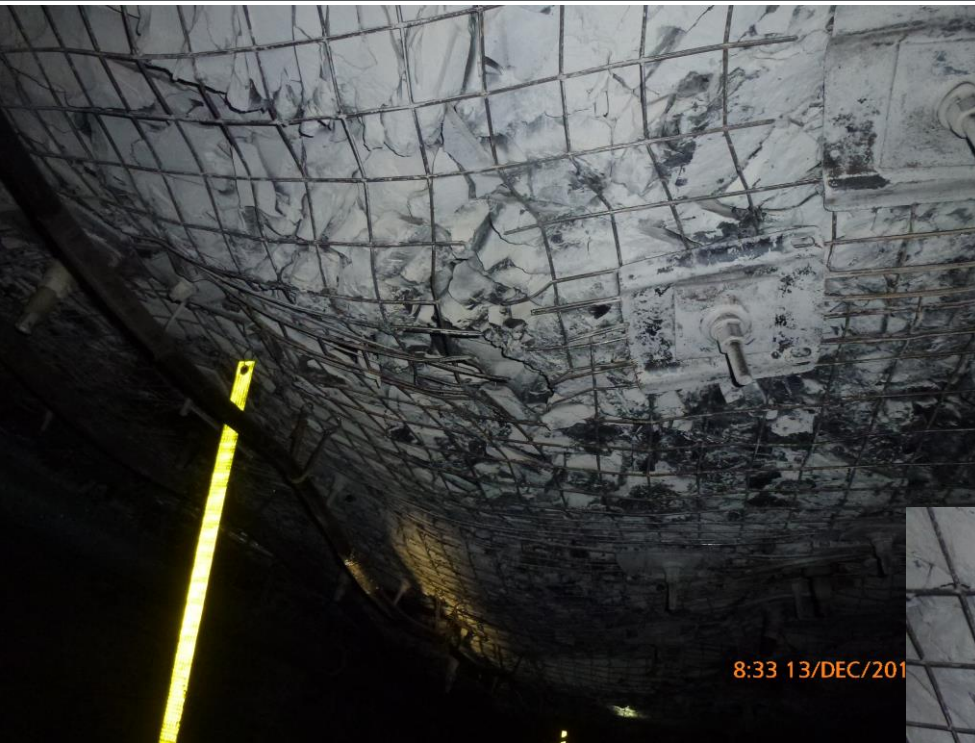
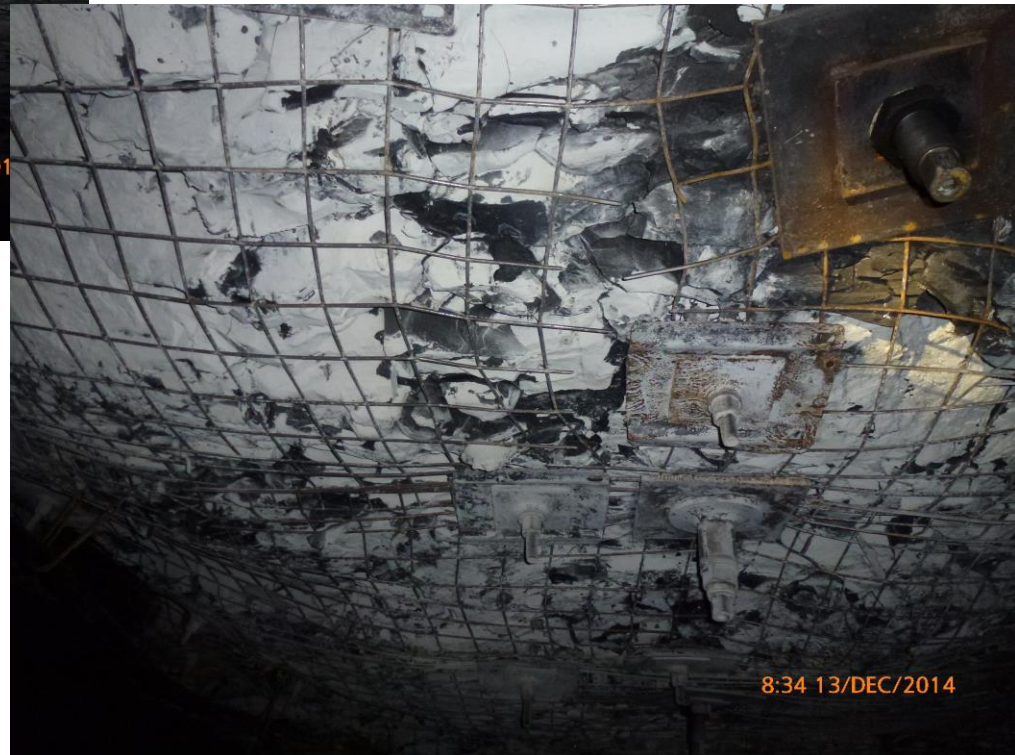
A HDG OUTBYE ROOF CONDITIONS

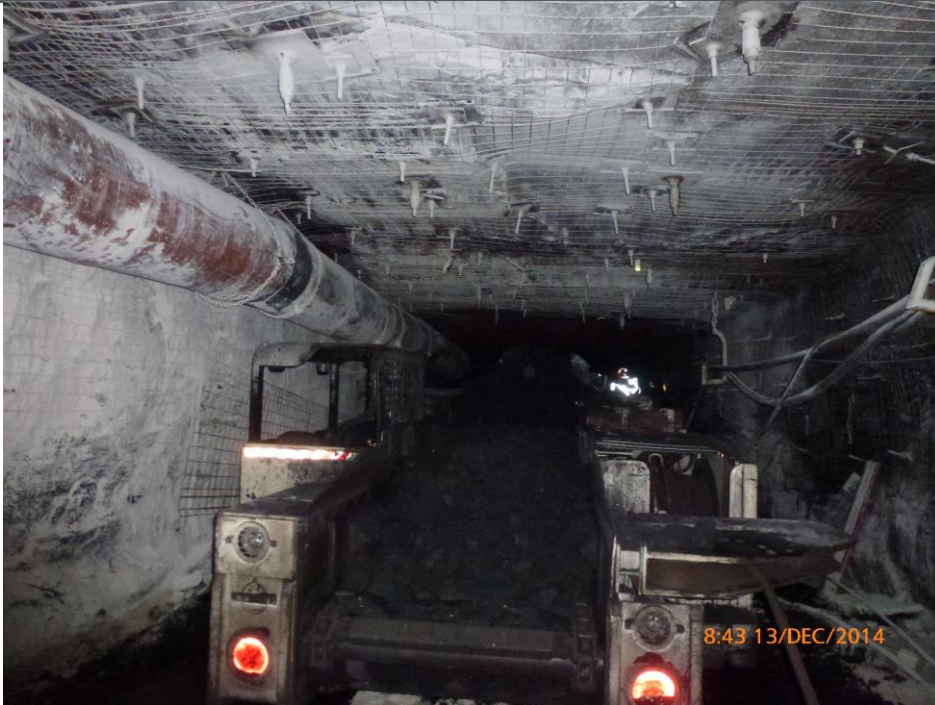
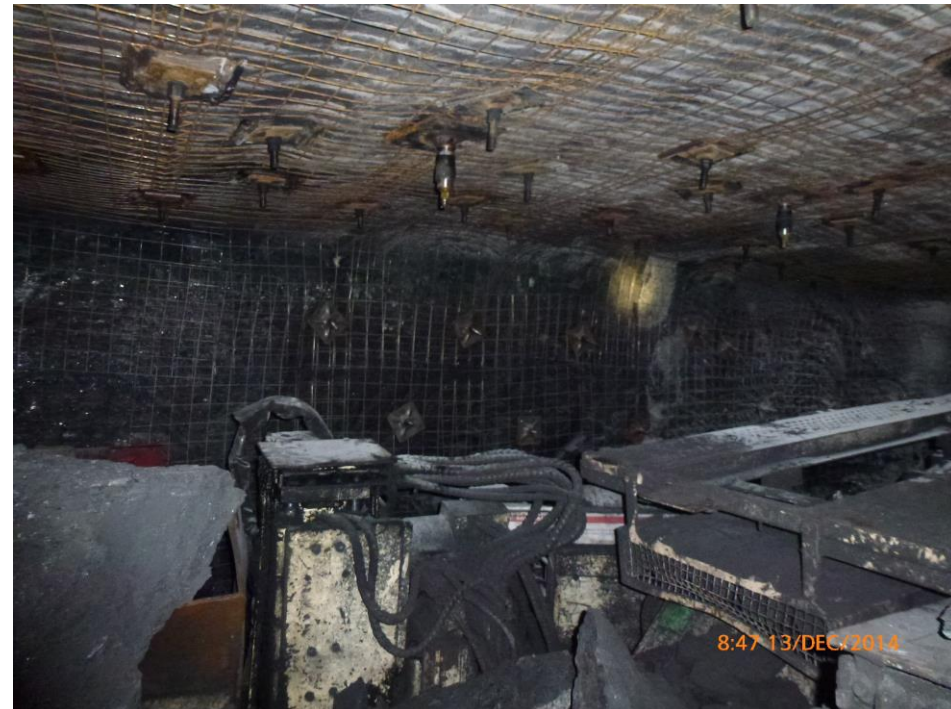
B HDG FACE ROOF & RIB CONDITIONS

- B Hdg had a significant change in roof conditions
- Rib conditions changed – hard upright ribs
- Mining in structured area (Faults and Dykes)
- Depth of cover over 400m
- Bumping
- Previous low level events in A Hdg

- Stress conditions in panel
- Depth of cover
- Small pillar between A and B Hdg
- Confinement of roadway front abutments with dyke structure
- Ability of cinder to build up strain / hold load until ultimate failure

- Proximity to Nepean River and gorge (Stress magnitude + changing DOC)
- Inseam gas pressure

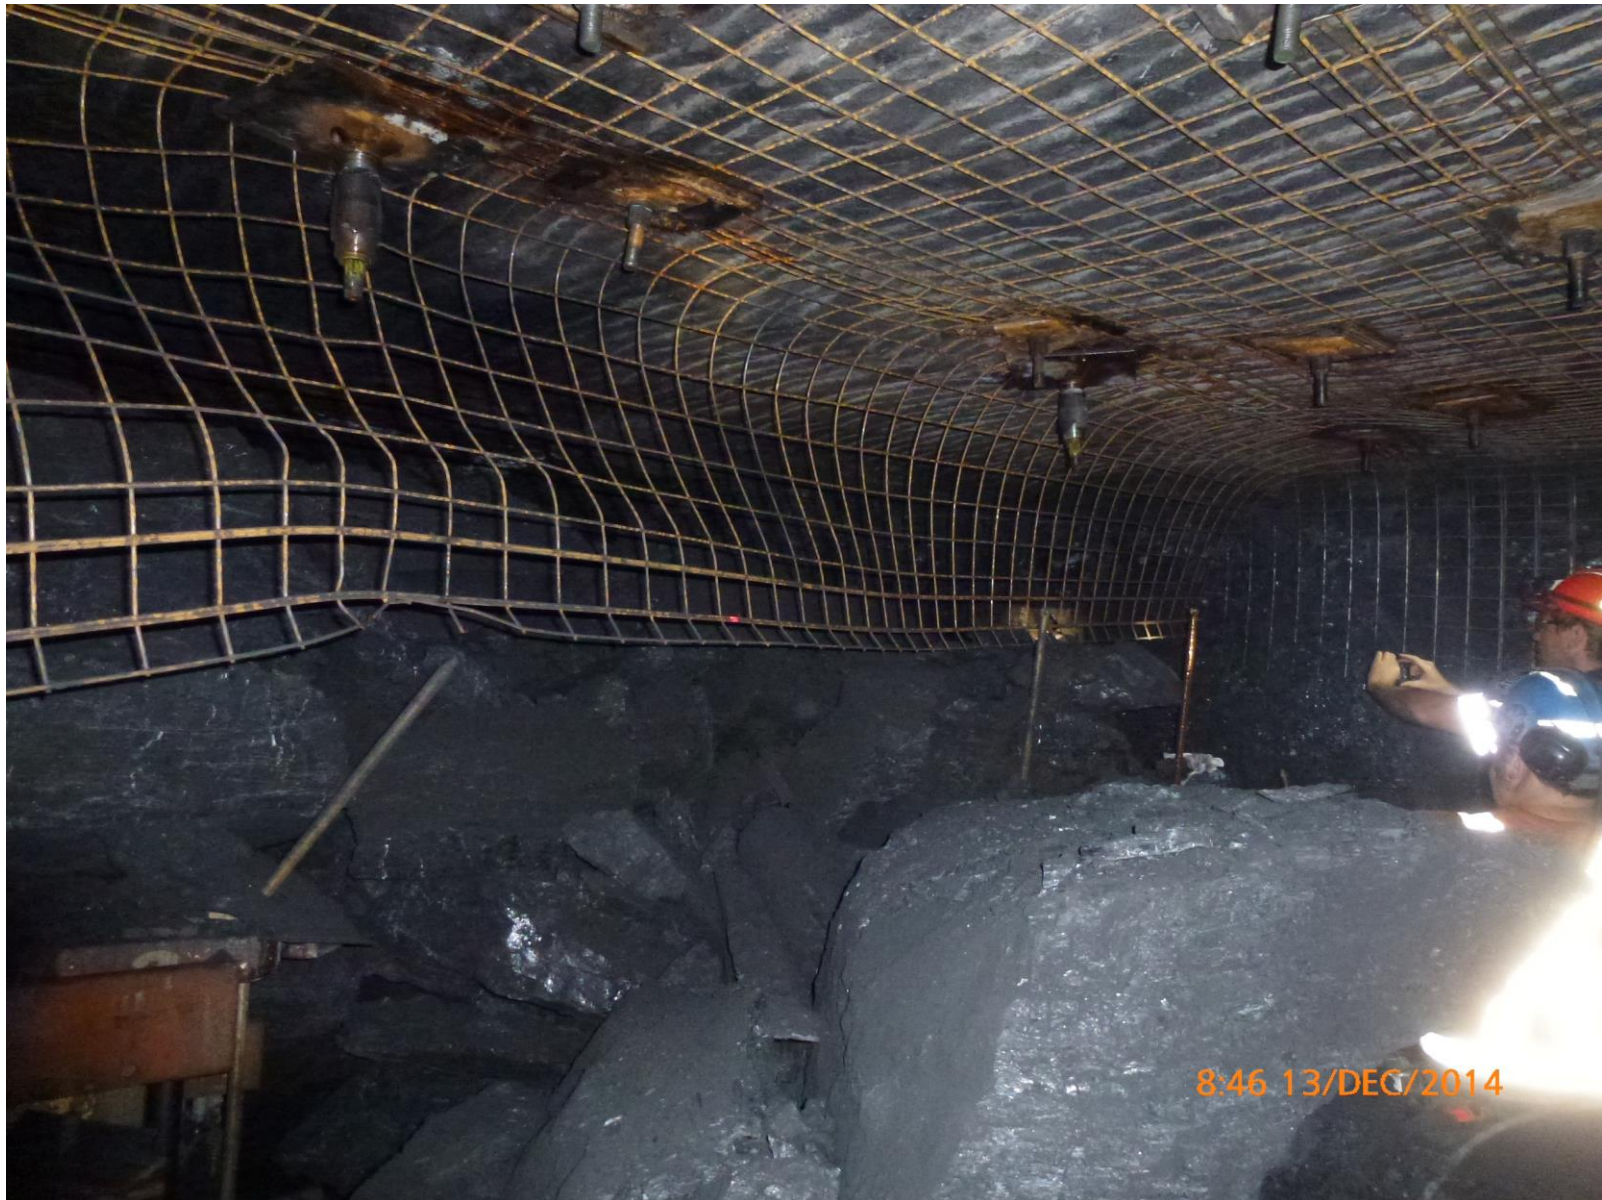
LARGE CINDER PIECE ON CM THROAT

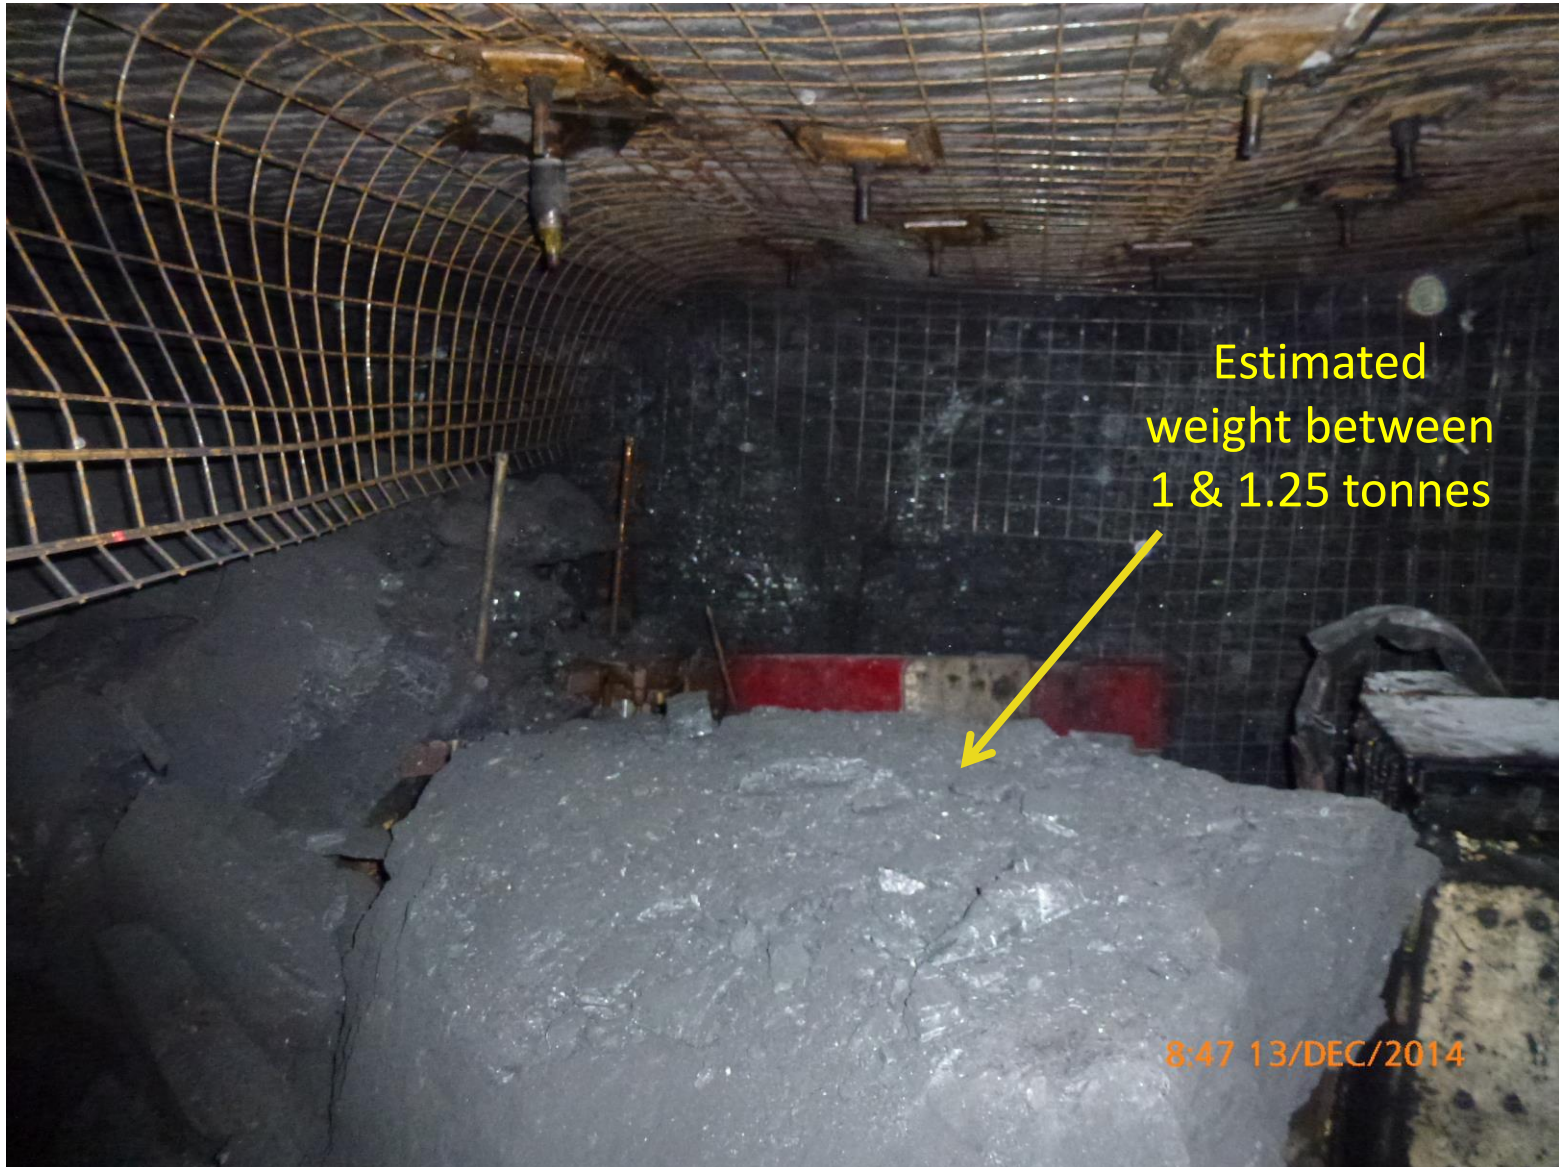
LARGE CINDER PIECE ON CM THROAT

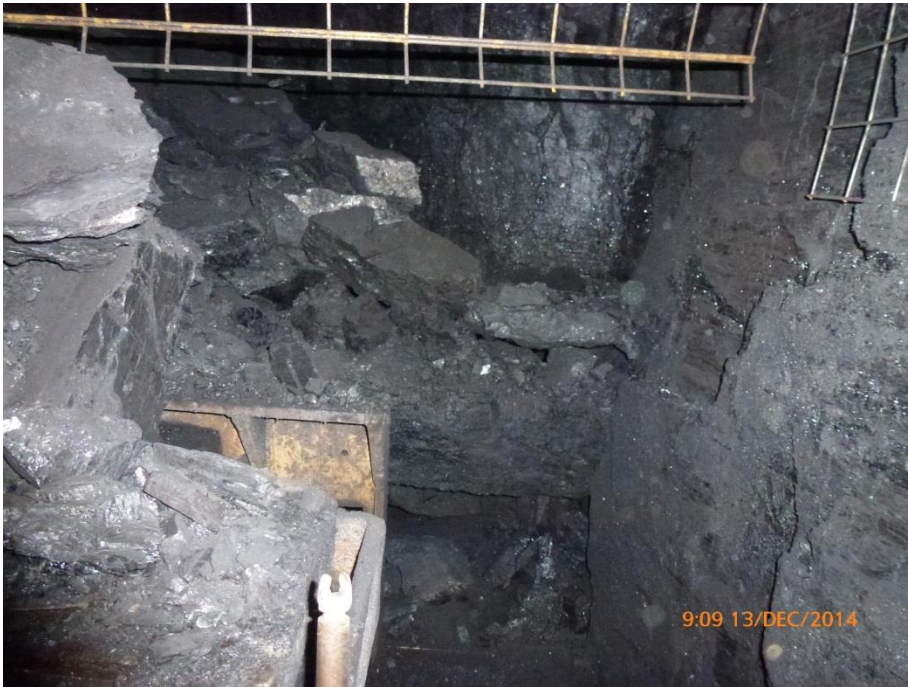
Rock Burst

Large big “Chunks” of coal

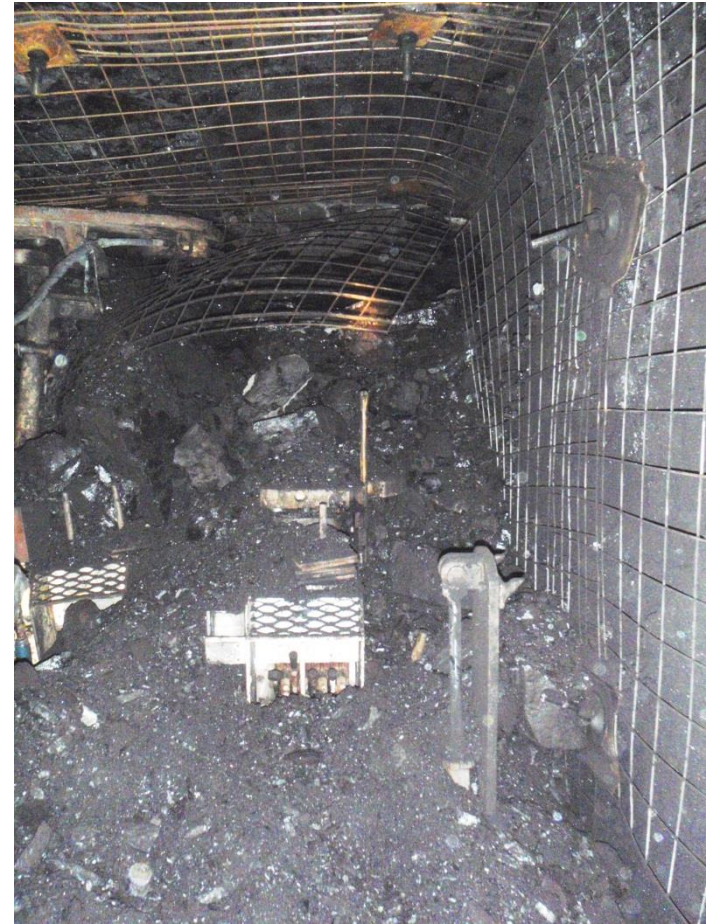
Gas Outburst

Fine pulverised pieces of coal

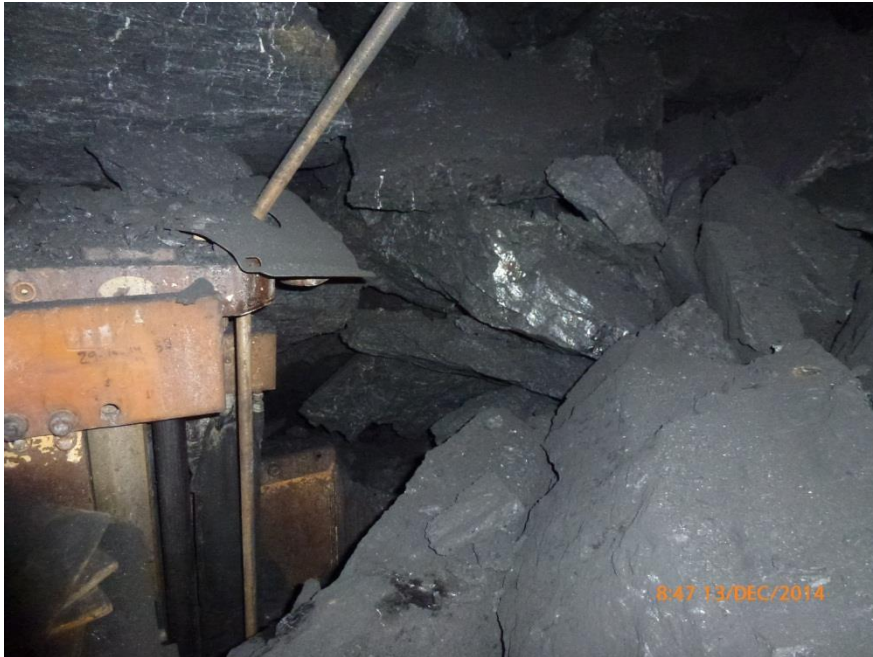
Rock Burst

Large big "Chunks" of coal

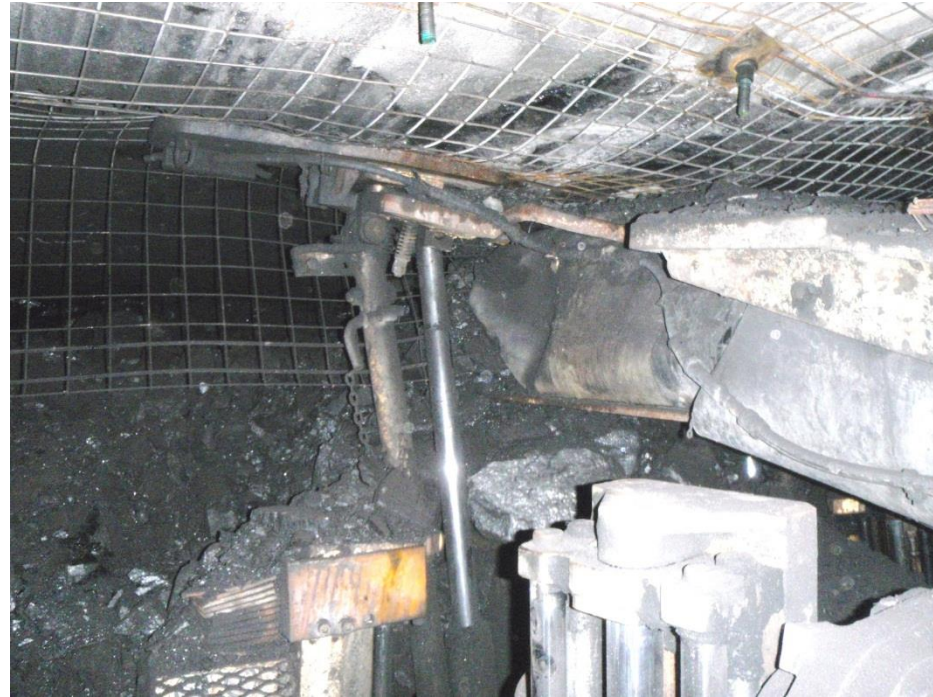
Gas Outburst

Fine pieces of coal

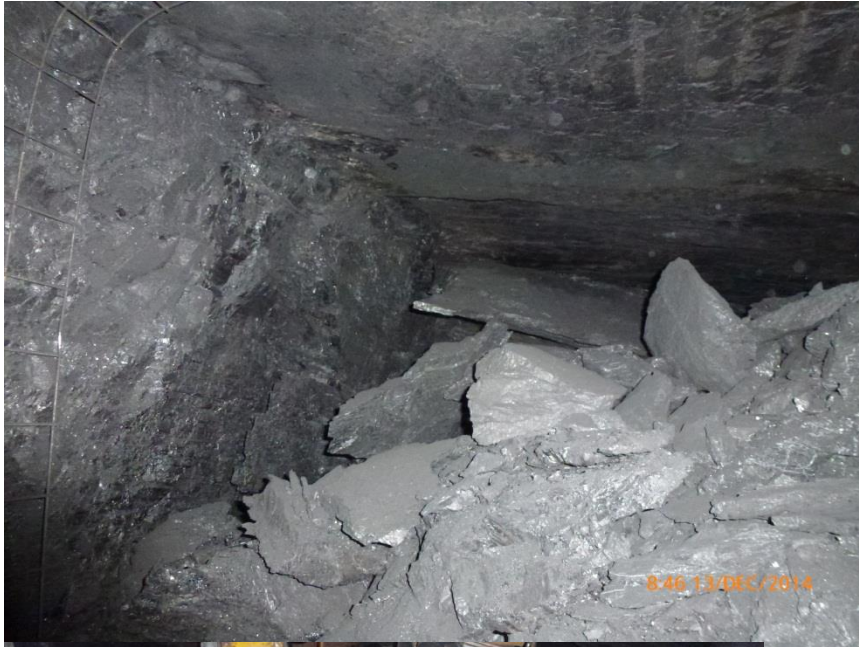
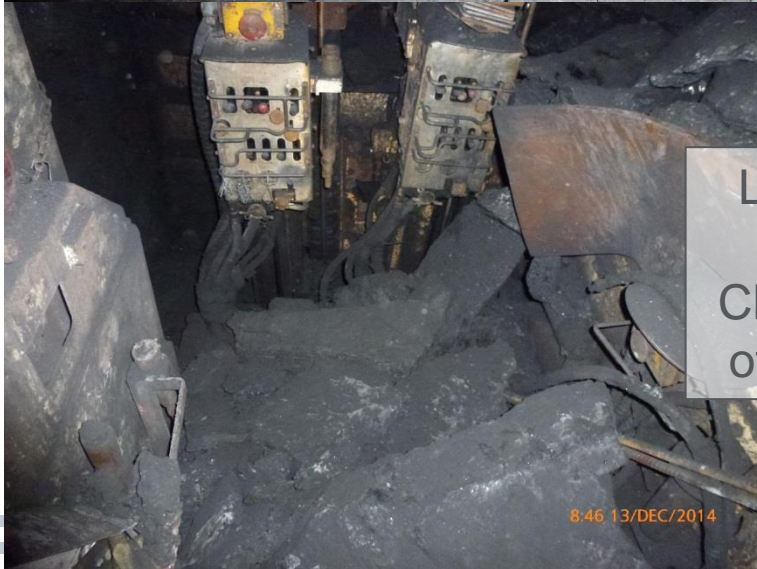
Coal Burst

Large
big
Chunks
of coal

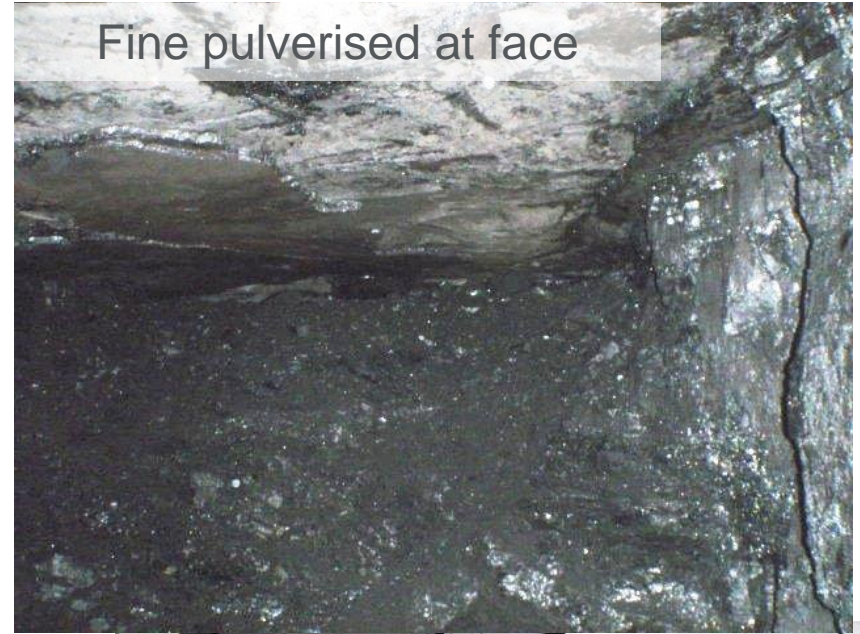
Gas Outburst

Fine pulverised at face

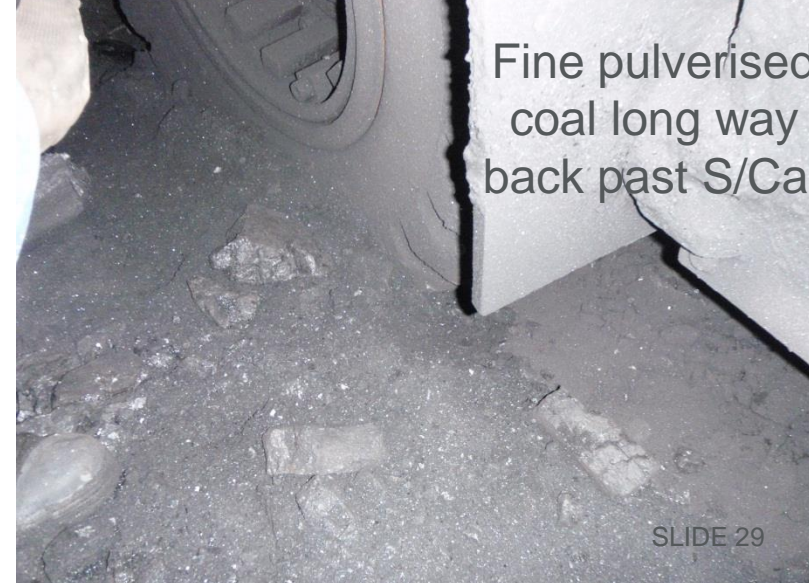
Fine pulverised
coal long way
back past S/Car
