Outburst Compliance Challenges Oakley #1 Mine MG33A_21-24c/t

Gas and Coal Outburst
Seminar, Wollongong,
November 2015

Oaky Creek Coal

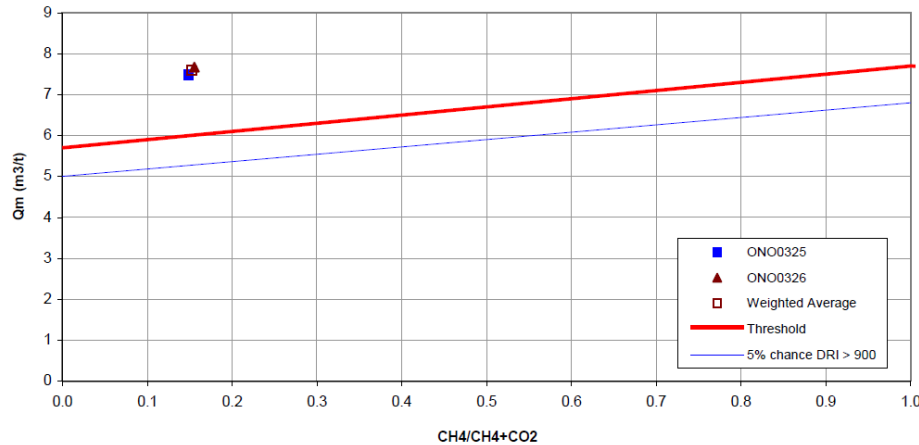
Gas Content Test Against Threshold
Gas Test Sub Samples

German Creek Main:

900 DRI determined threshold line runs between:

- 5.7m³/t @ 100% CO₂, and
- 7.7m³/t @ 100% CH₄

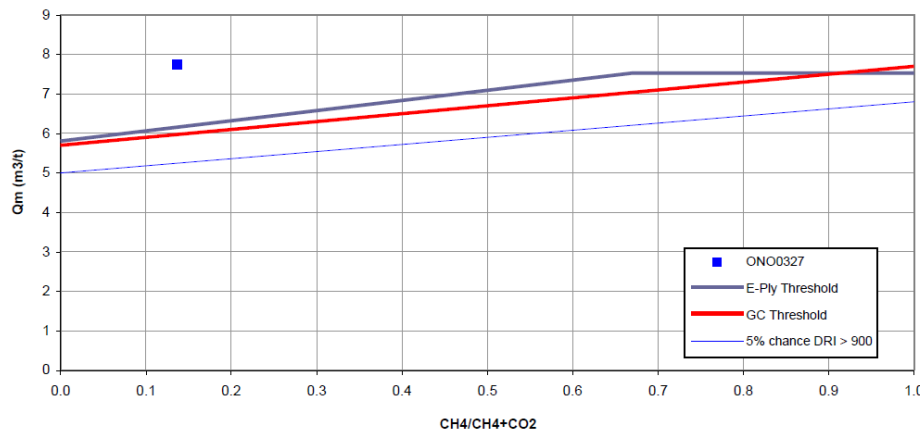
Gas Content Test Against Threshold
Gas Test Sub Samples

German Creek E ply:

900 DRI determined threshold line runs between:

- 5.81m³/t @ 100% CO₂, and
- 7.53m³/t @ 67% CH₄, flat thereafter to 100% CH₄ until sufficient high methane coal samples become available.

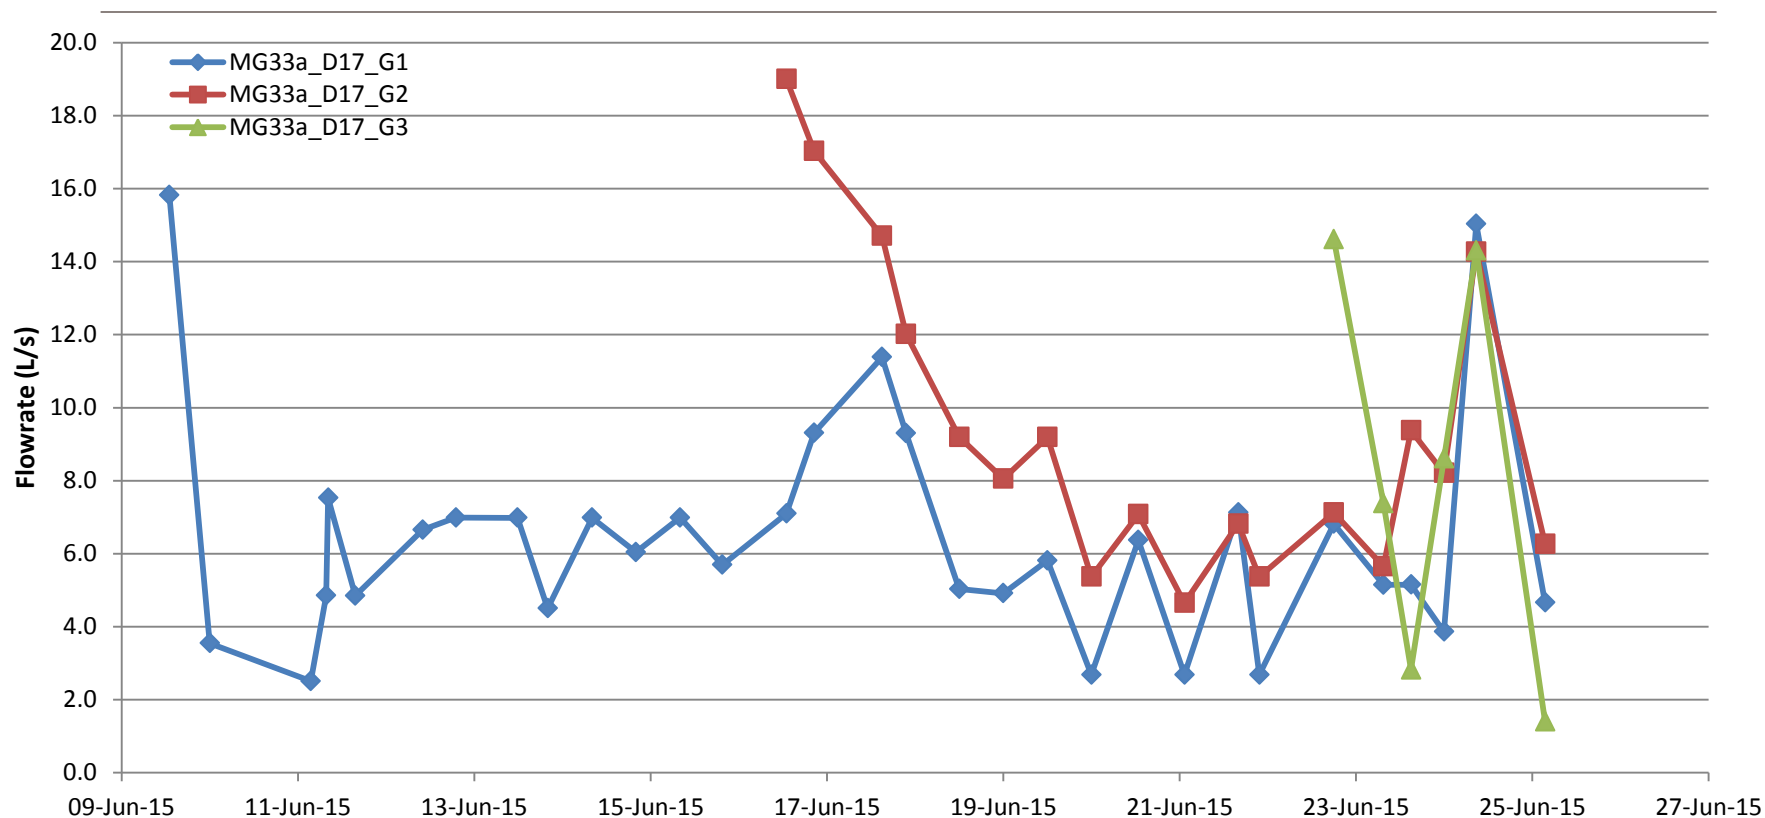
Additional Borehole Performance

- Cores were 80 to 85% CO₂
- Borehole drainage was very slow
- Area appeared to have a very low permeability
- Development forecast was not achievable with existing draining system results

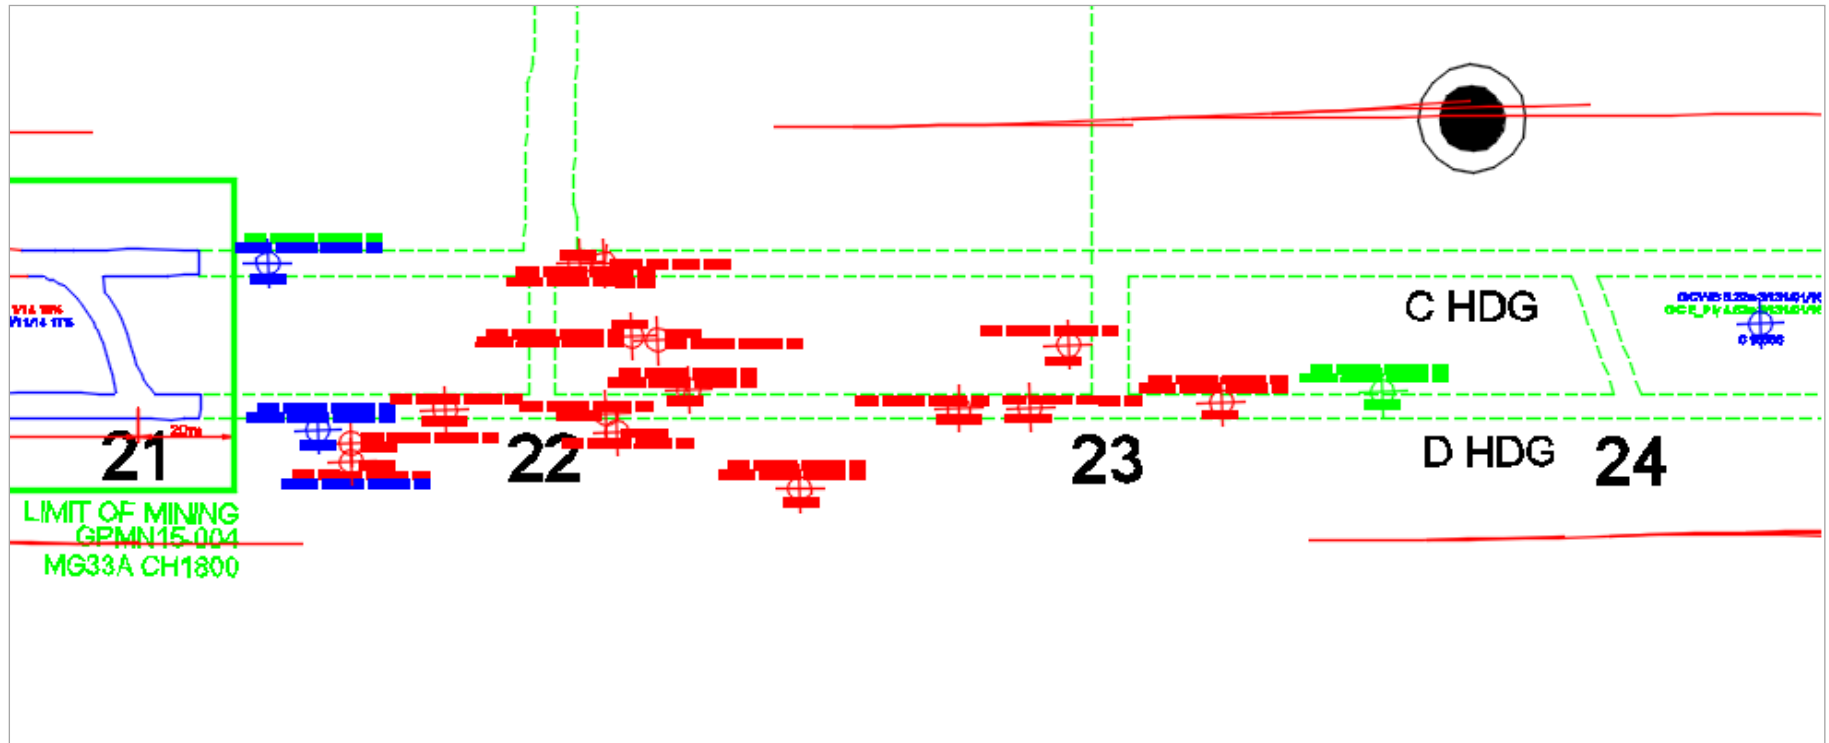
Mining ceased at the 21ct line

- A sea of red ‘failed’ compliance cores ahead in amongst the SIS drainage gap.
- The additional UIS phases (not shown) had not rectified the situation.
- Inbye of 24ct through to 43ct, all core results were below threshold.

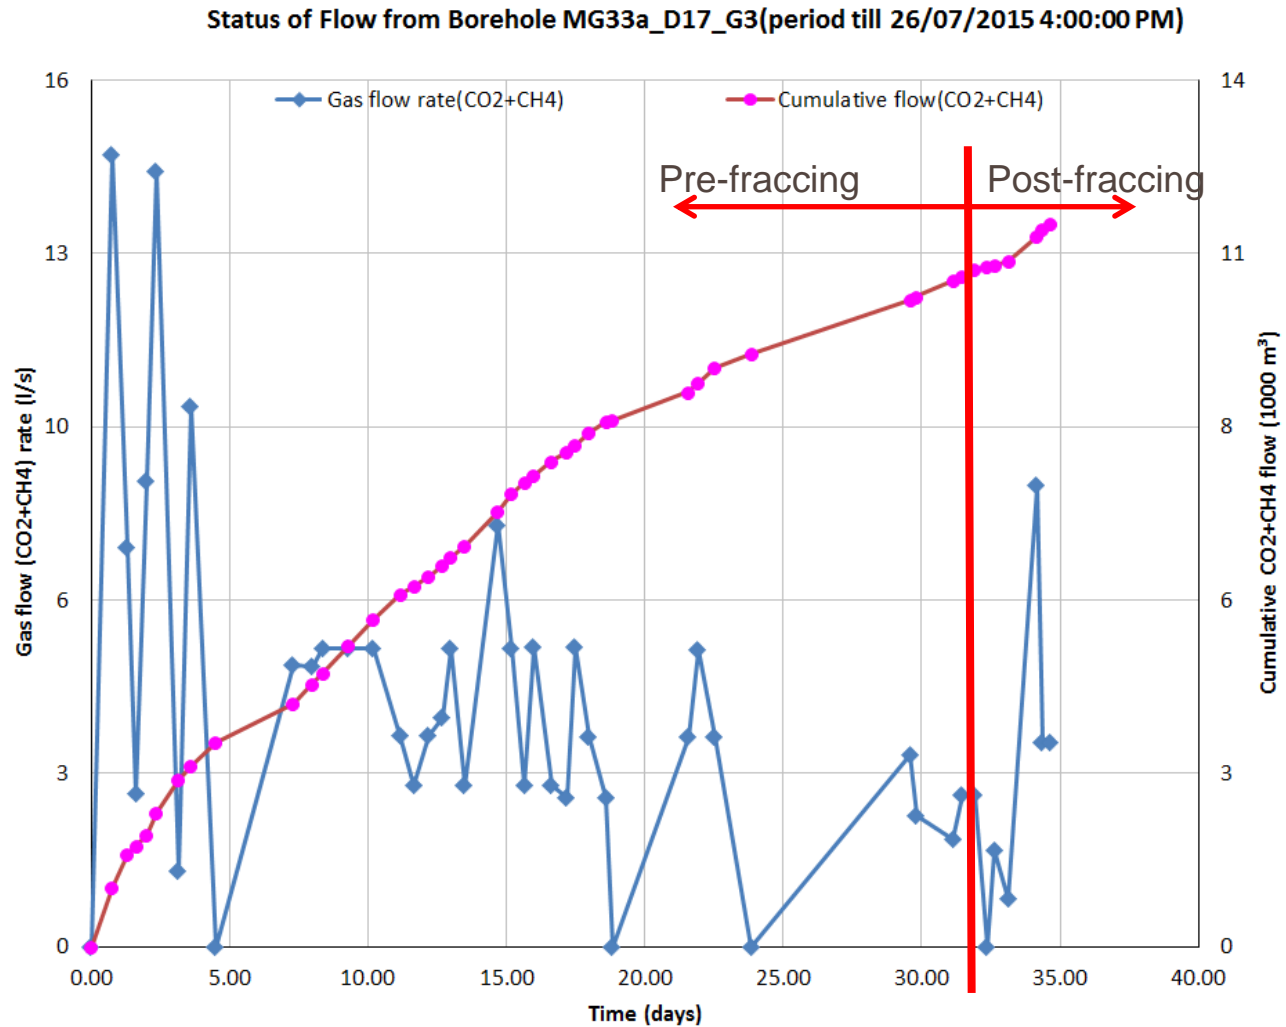
Updated Borehole Performance

There were increased gas flows in some boreholes post fracking, but generally low and sporadic.
