Advanced Energy

Standpipe Rupture

17/11/2016

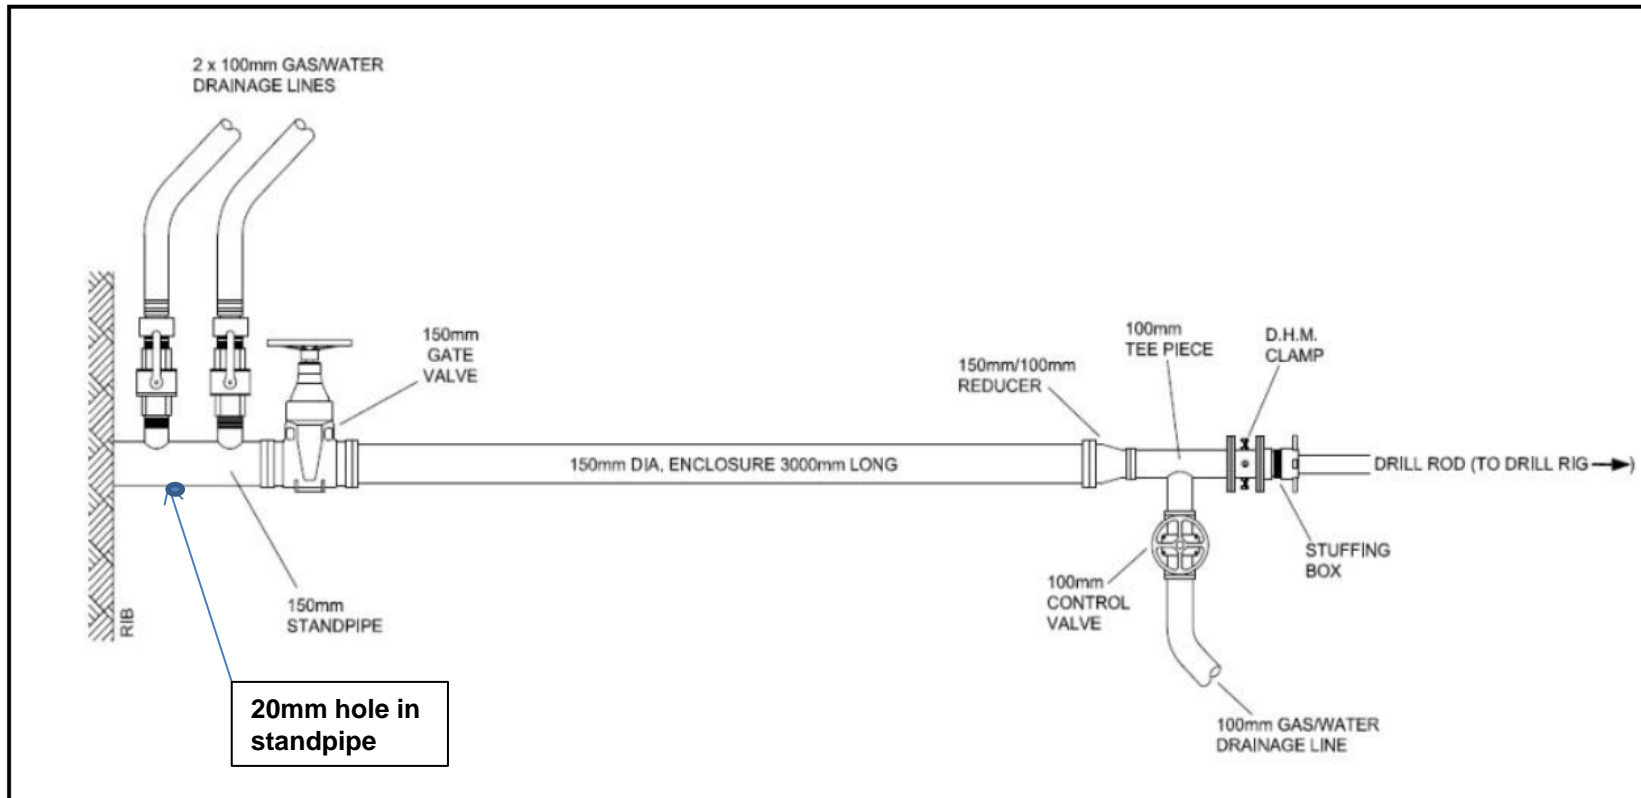
Figure 2: Standpipe configuration with 3 m enclosure

Standpipe set up

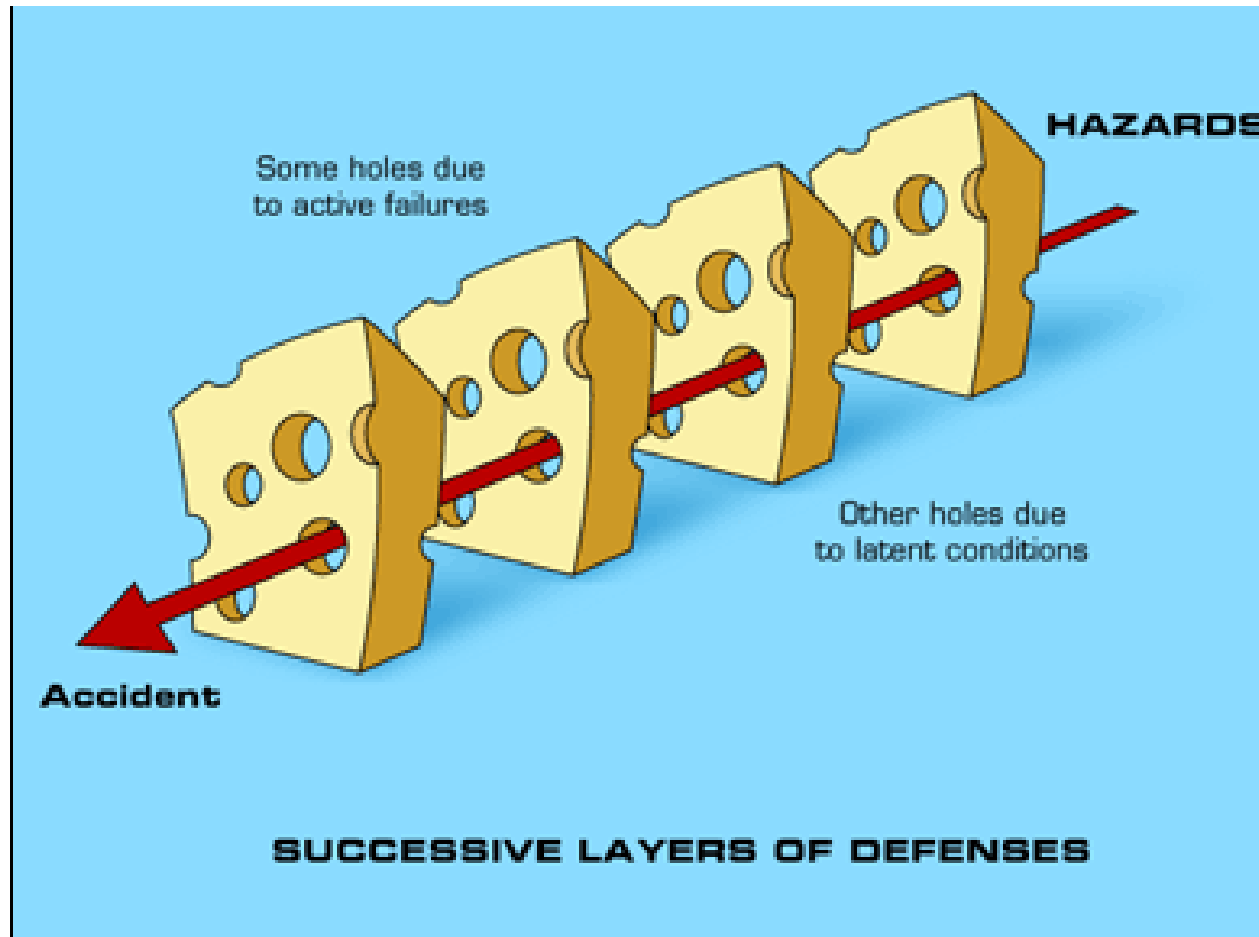
So what went wrong?

- One of the drill crews had previously identified a small leak in the bottom of the standpipe and had sealed the leak with grout.
- Standpipe turned off at 11.30 am and grout patch fails under pressure
- Subsequent examination showed a hole 30mm diameter worn in bottom of standpipe -

- Back pressure caused grout repair to fail, releasing seam gas under pressure
- Ventilation increased to stub – remaining bores turned back on.
- Incident reported to regulator – Clause 179 – uncontrolled escape of gas
- Site sterilized by regulator – drilling suspended until original standpipe integrity able to be re-established
- Review of procedures and processes carried out.

- Boreholes were turned off to rectify gas water separator problem
- Rib line was under-cut where standpipe was installed – increasing length of exposed standpipe
- Standpipes had only single layer of Kevlar wear protection – no prior knowledge of wear associated with this length bore
- Gas range and drill rig location compromised separator set up
- Back pressure in gas range from first drill site bore holes

- Bolt down feed frame holes were of greater diameter than bolts – rig was able to move slightly under load
- Increasing curvature on boreholes with greater deflection on drill string
- Closed circuit set up
 - Placed rig six metres from standpipe allowed for further deflection
- Leakage from standpipe not identified as issue by drillers

- Consultation with standpipe OEM
 - OEM supplied composite adhesive – additional layers glued on and covered with steel pipe bandage.
- A test standpipe was set up to test and pressure tested to OEM specification before repairs to damaged standpipe carried out
- All standpipes were examined for damage
- External sleeves bonded to all standpipes
- Procedure to inspect drill rig hold down bolts each shift and chain blocks used to lock rig alignment

- Gas separator – separate gas line - run into return – not into gas range
- Training of crews in procedure to bond sleeves to standpipes
- Retraining of crews in procedures to set up each standpipe and monitoring requirements of rig position each shift
