# Appin Colliery

## MG703 Outburst Presentation

Gas and Outburst Seminar  
25<sup>th</sup> June 2009

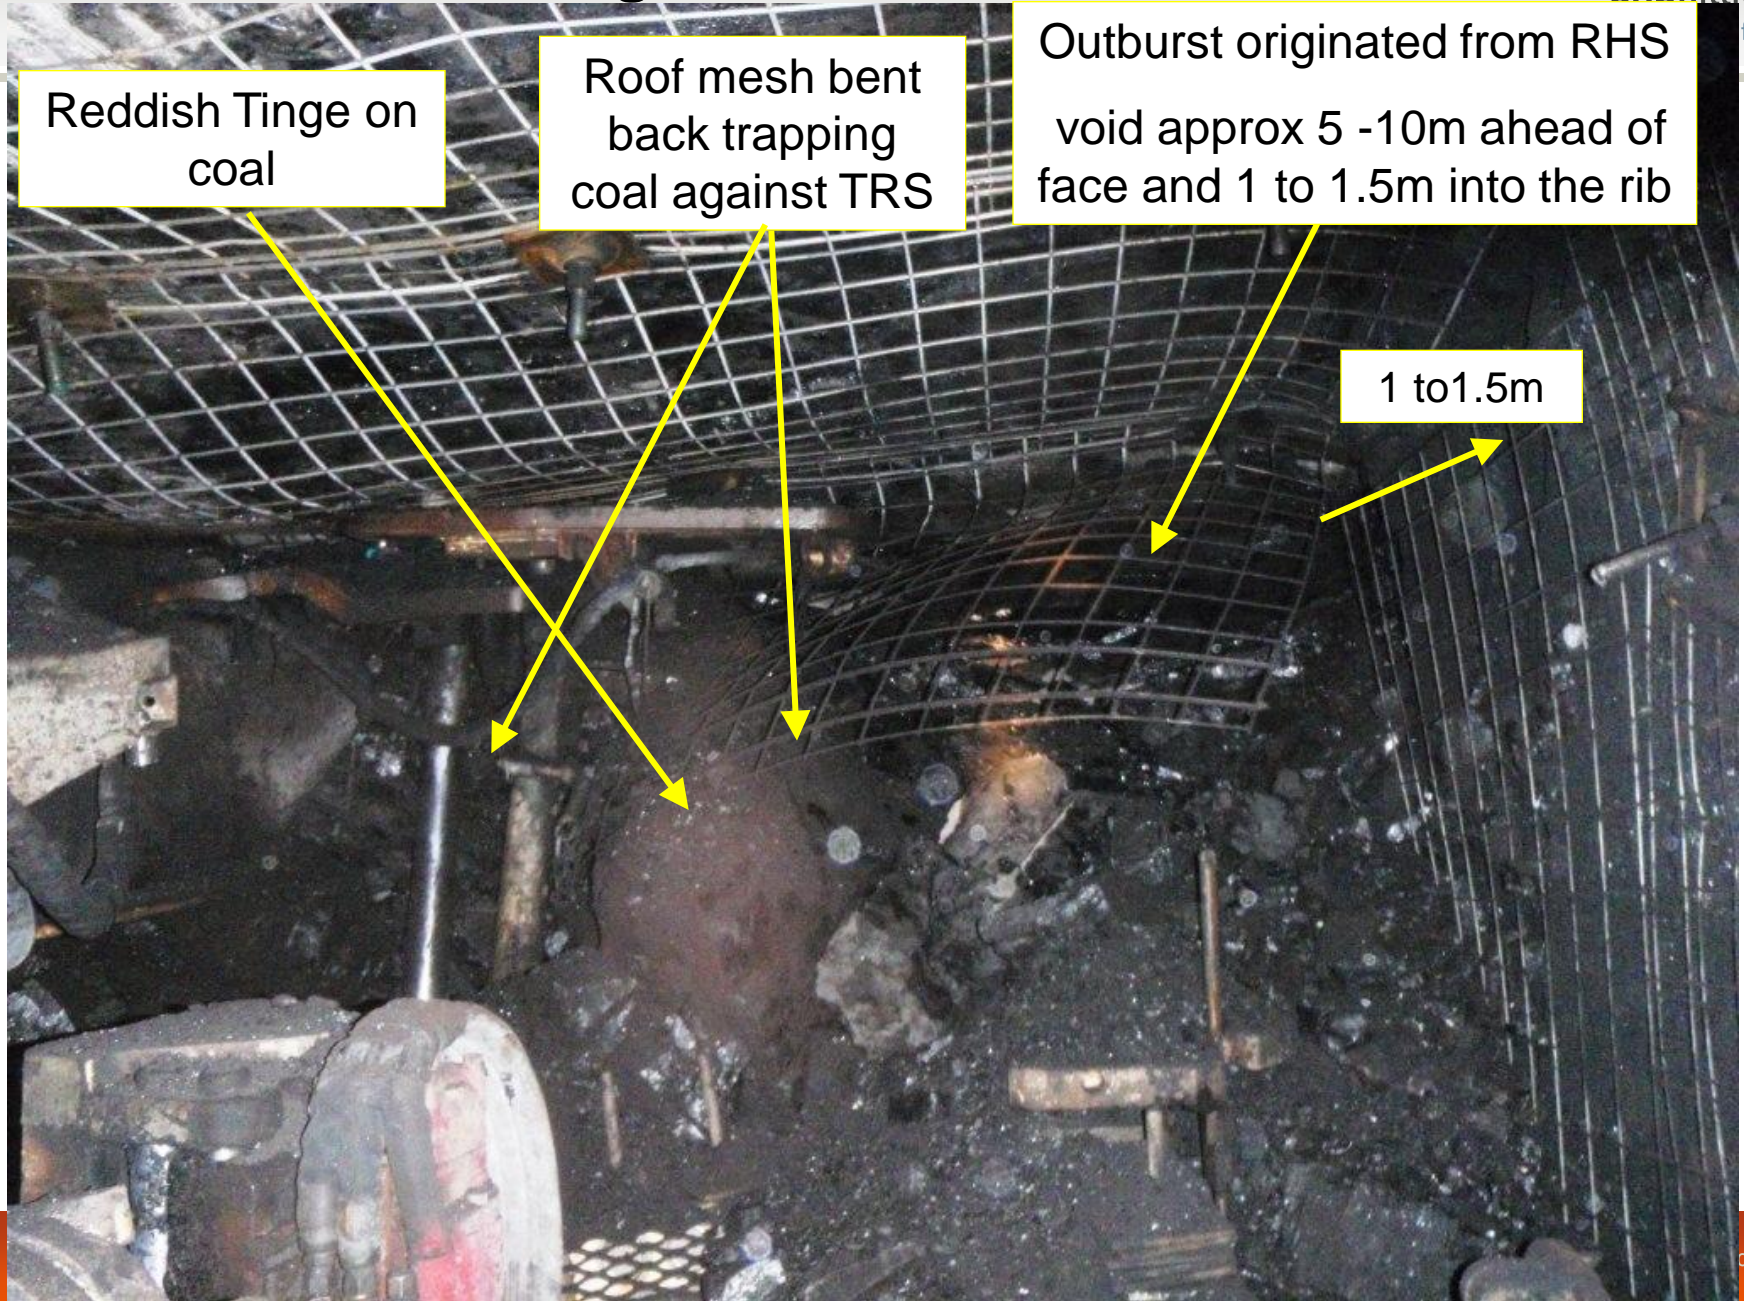
# RHS of ABM looking towards face void

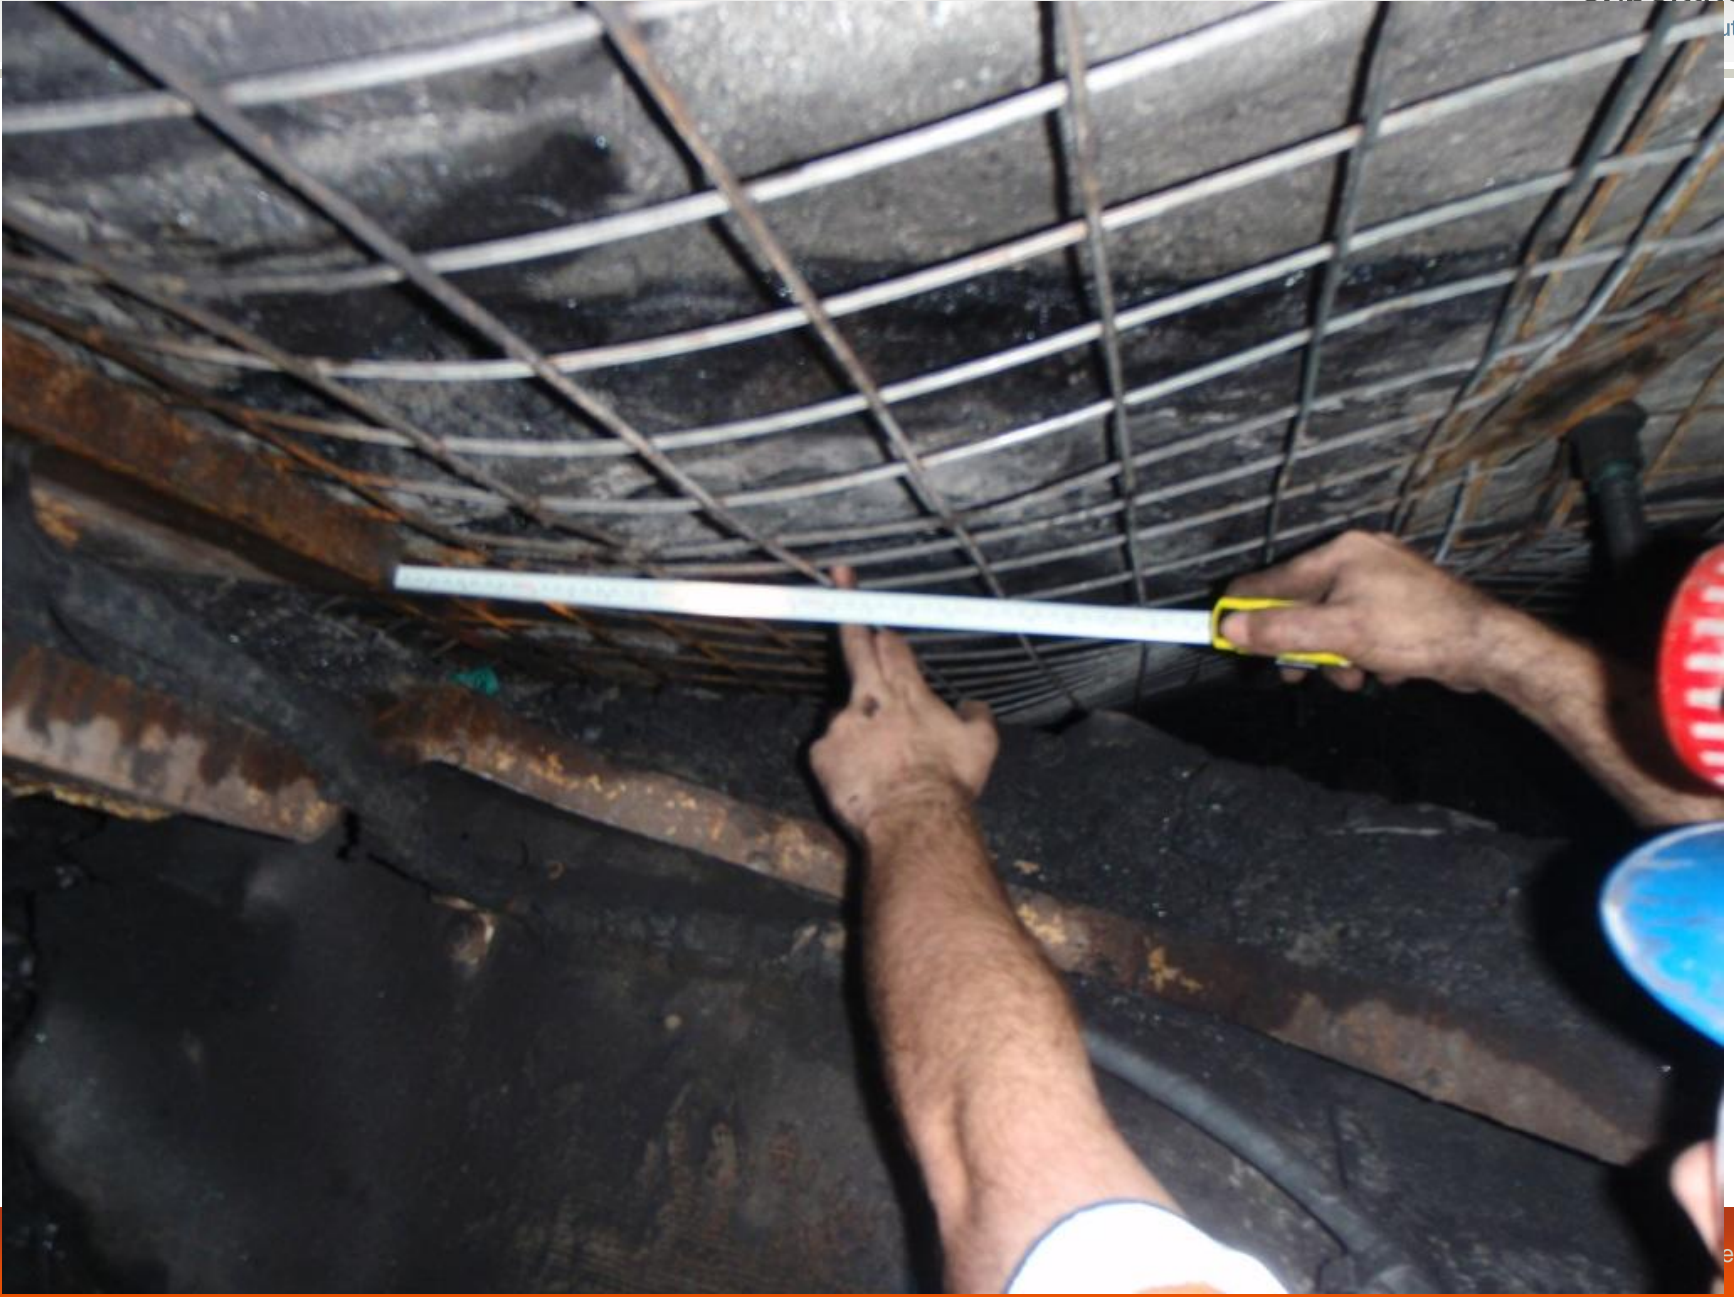
- It took 6 hours to degas the heading to gain access to the face – Centre line brattice erected prior to fan starting.
- On safe inspection of the face the ABM20, with canopy set to the roof, had been pushed back approximately 500mm.
- The maximum percentage of methane recorded in the panel return was 1.5%.
- The face position was 74m inbye B 18Line, (Approx 50m into boggy zone)
- There were no recorded increased gas levels detected in A Hdg (as recorded by the real-time monitor at 18A Hdg).

## CM pushed back nominally 500mm – Canopy set to roof

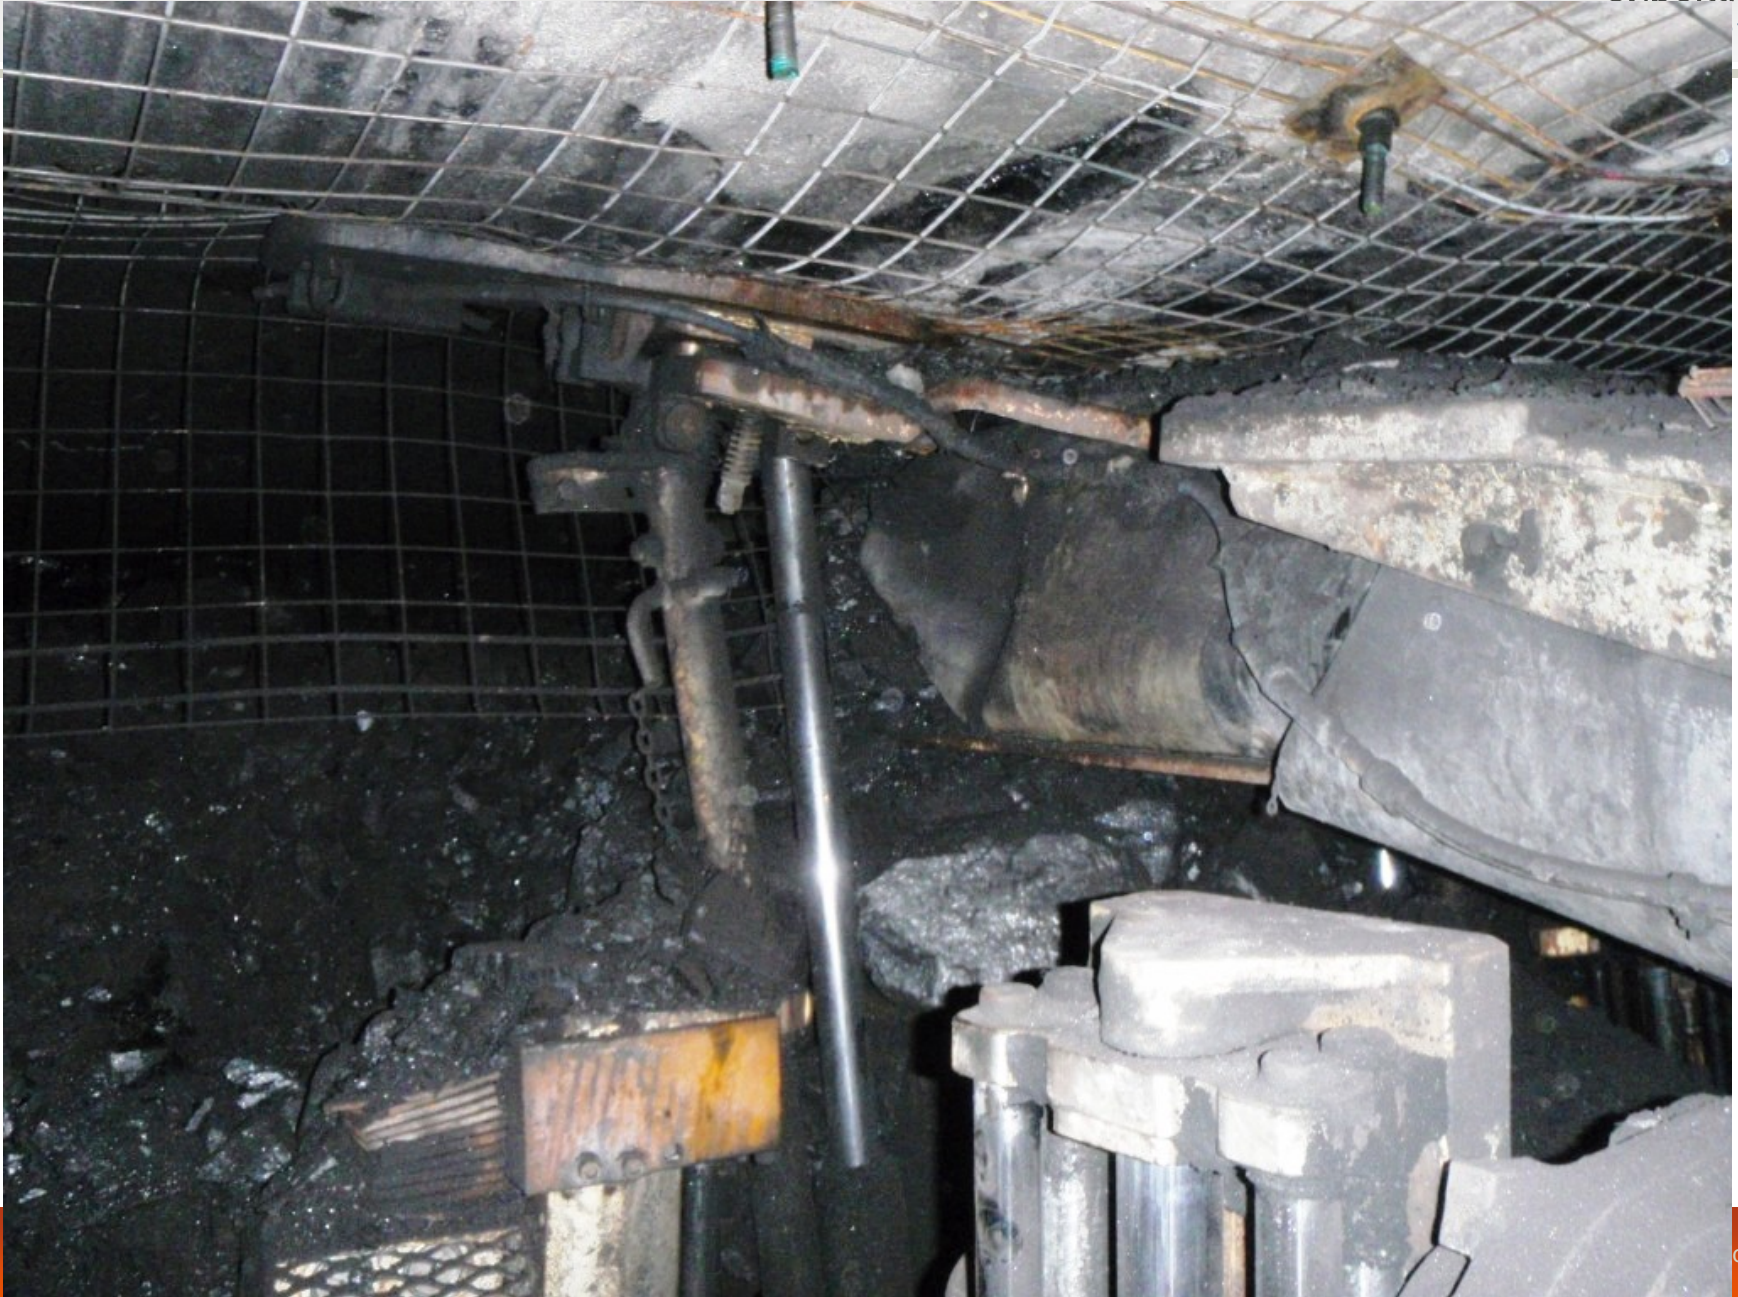
## LHS of ABM – Mesh bent back trapping coal against TRS

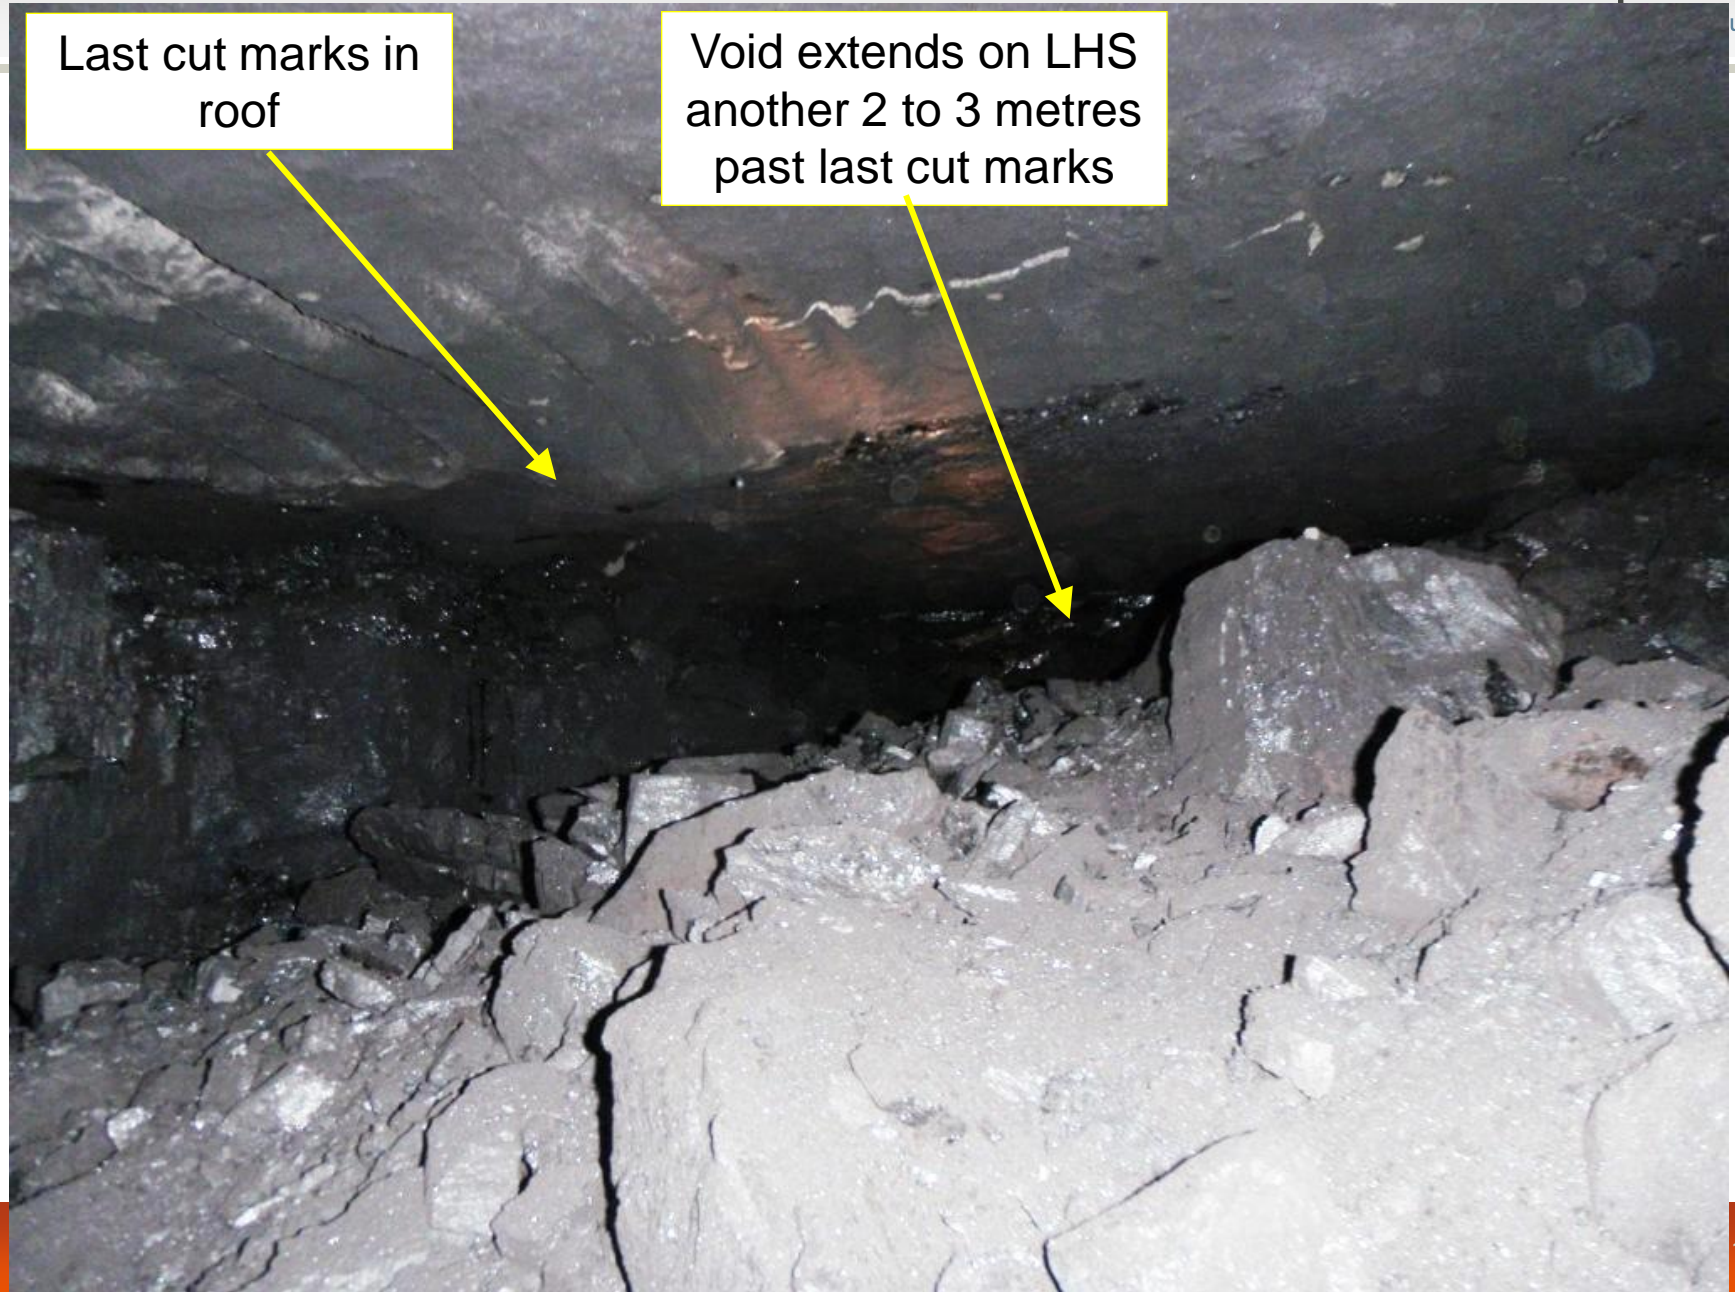
# LHS behind Mesh looking into void

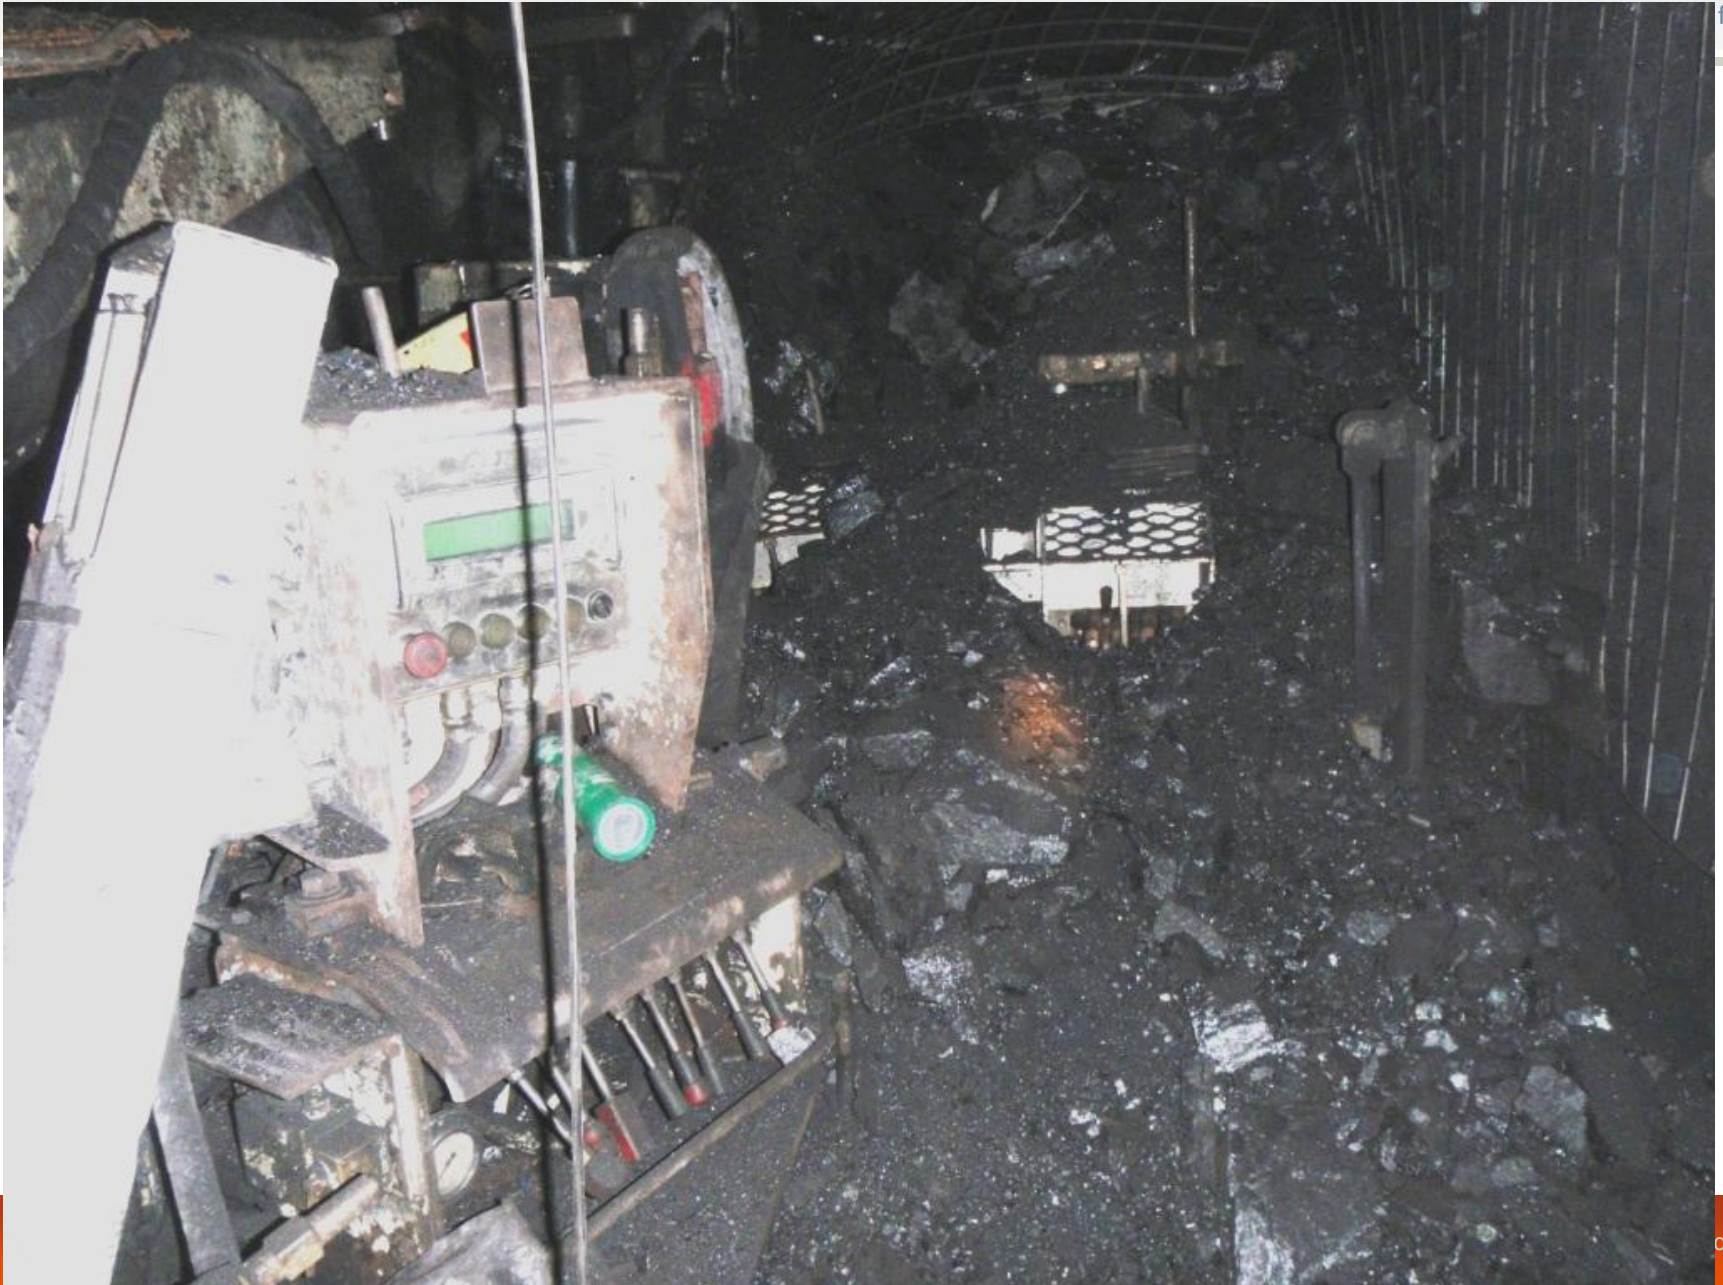
# RHS ABM – Coal thrown back covering platform

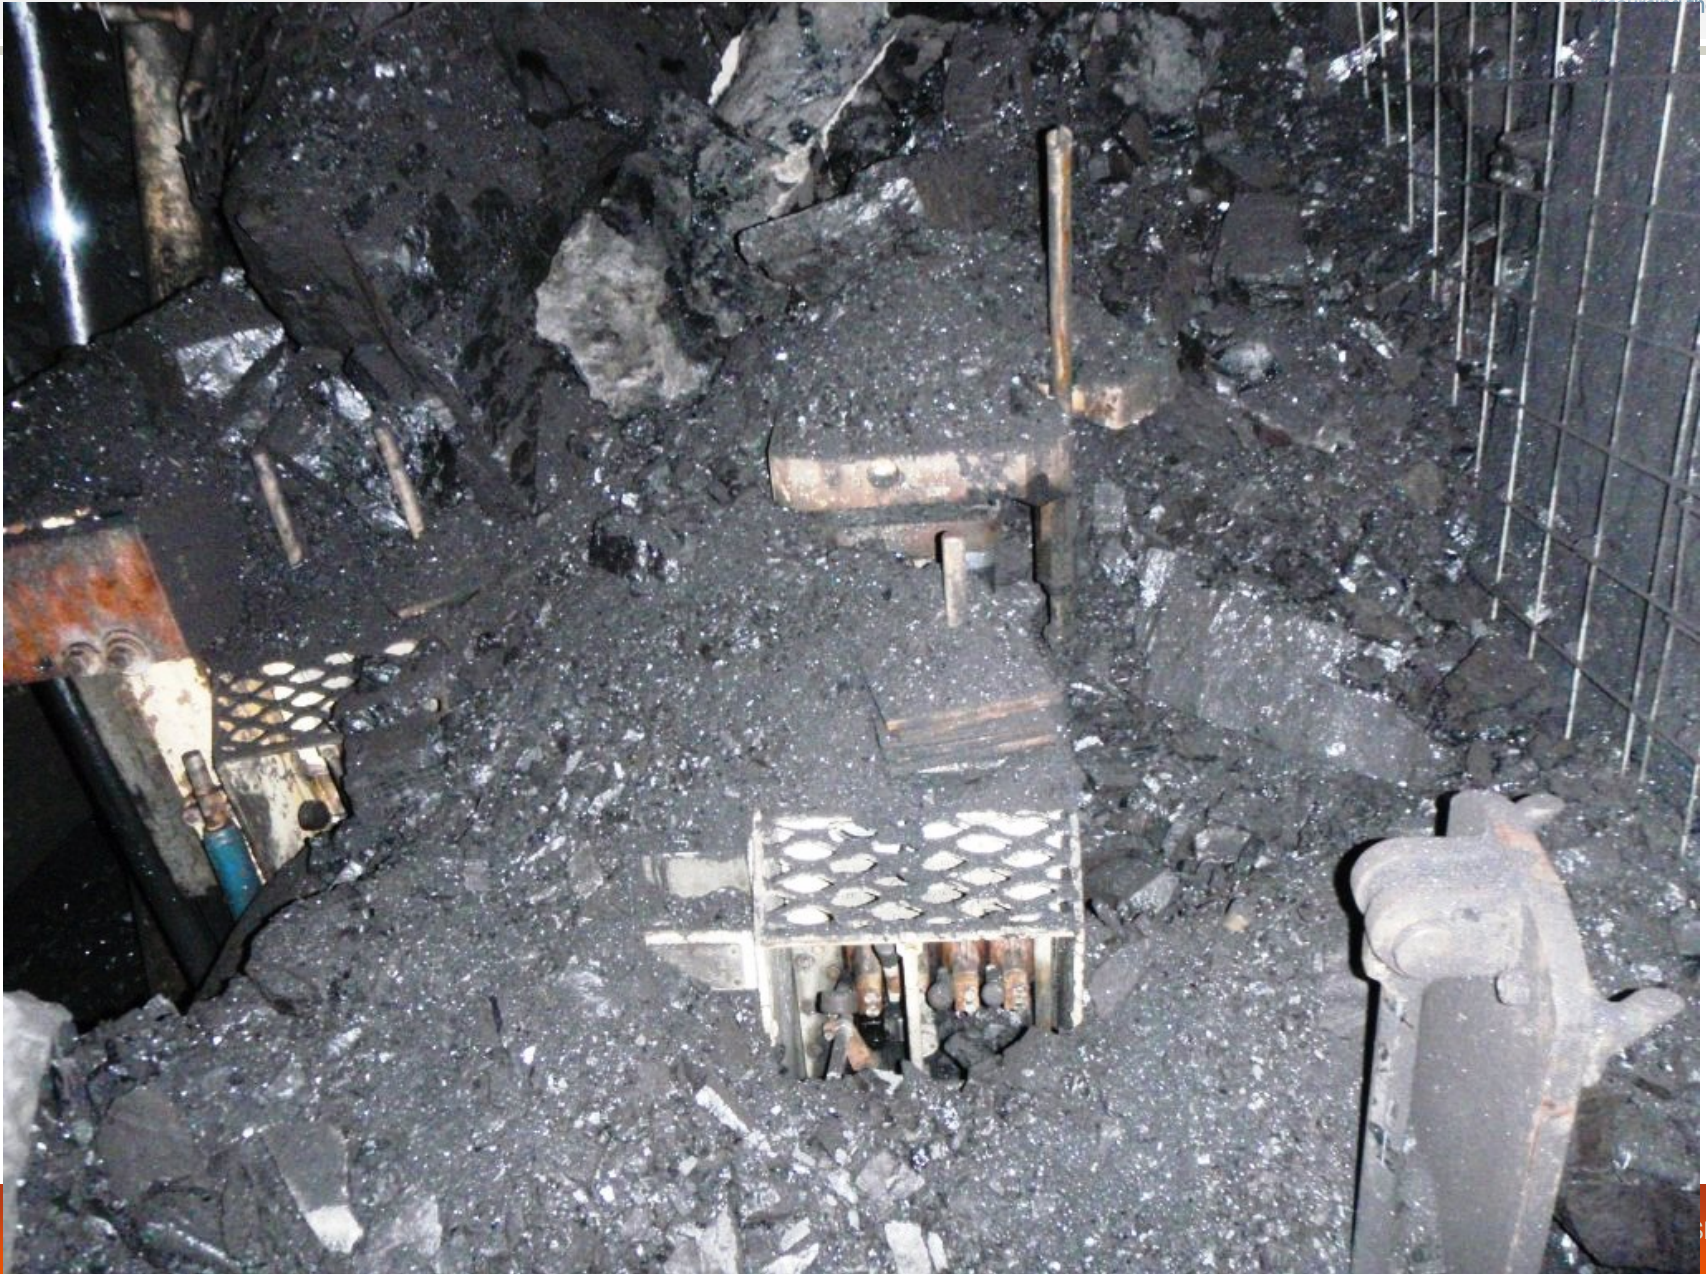
# RHS of ABM – Coal back over bolting station

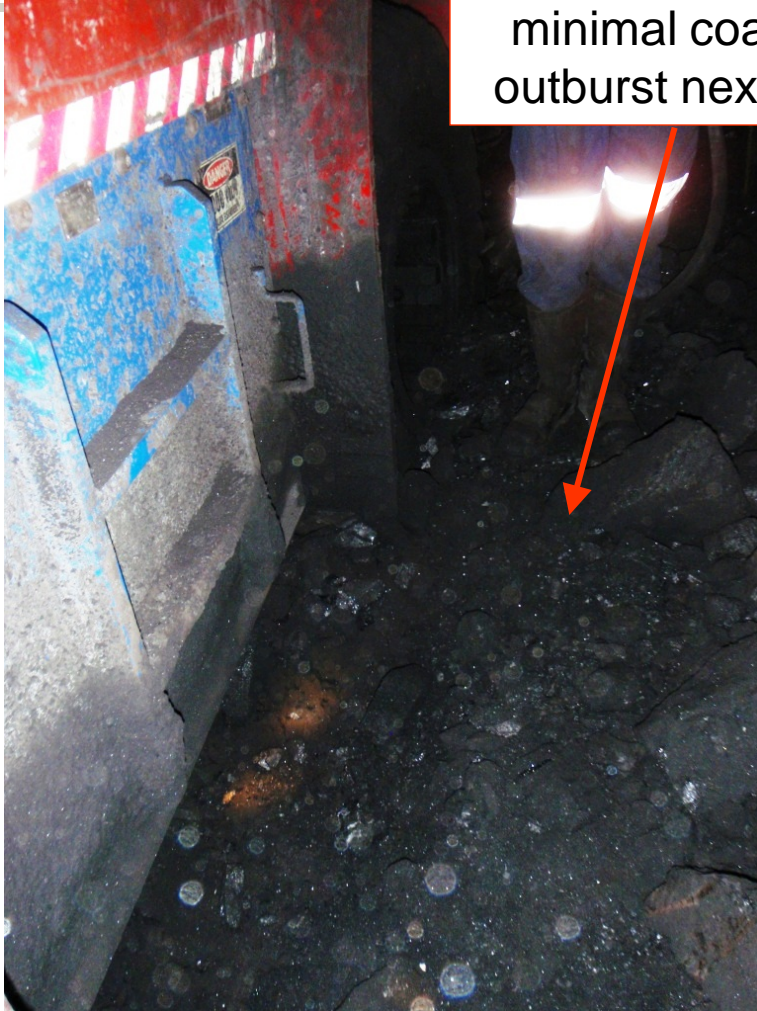
# RHS of Shuttle car – pushed back

minimal coal from  
outburst next to car

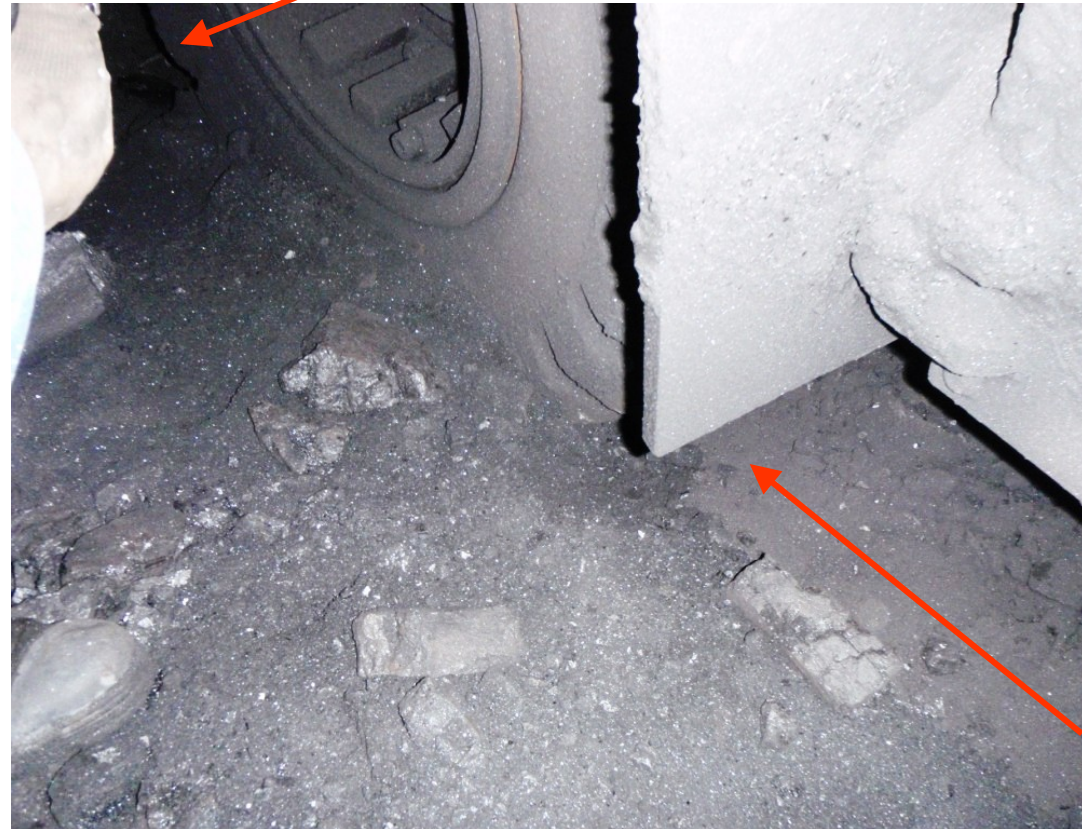
Pile of coal pushed in  
front of outbye end of  
wheel

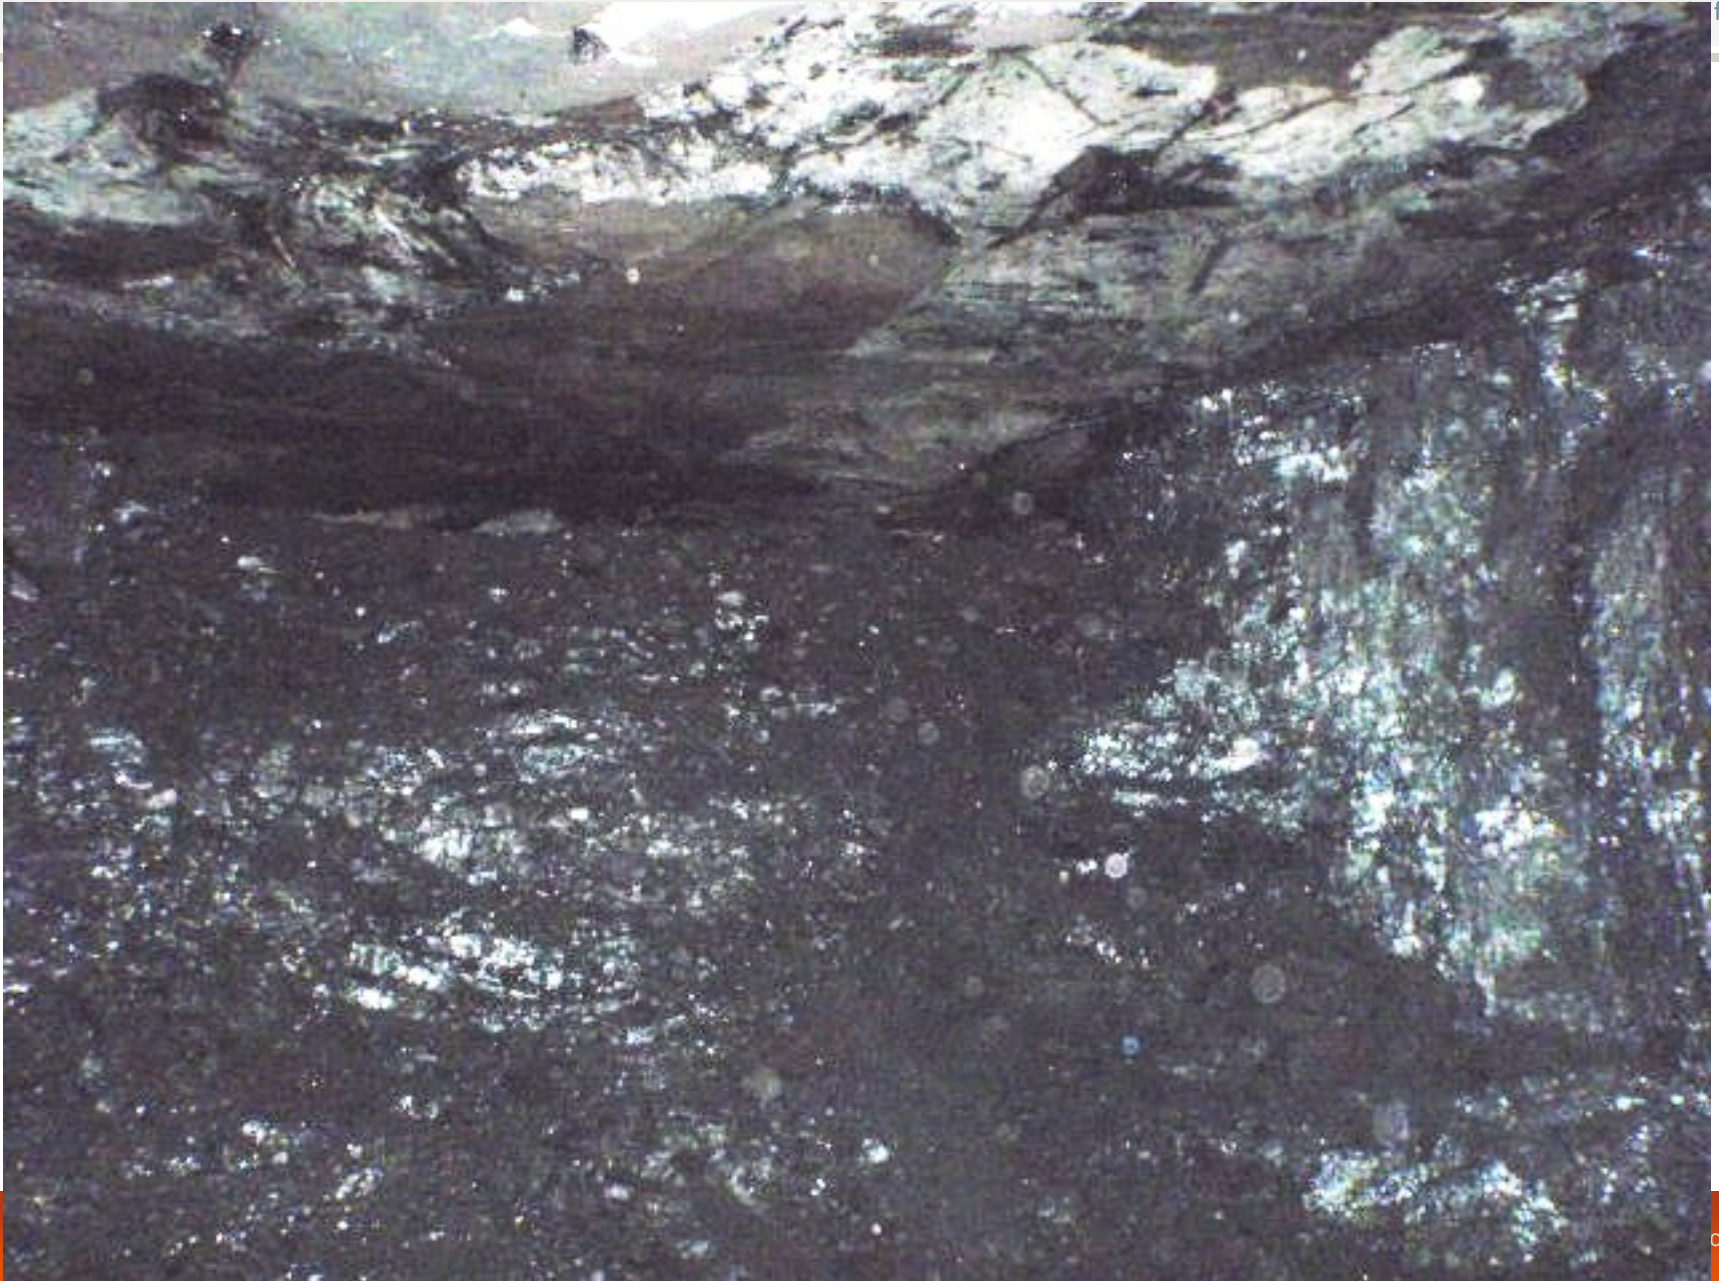
# Outburst Void RHS – Once coal loaded out

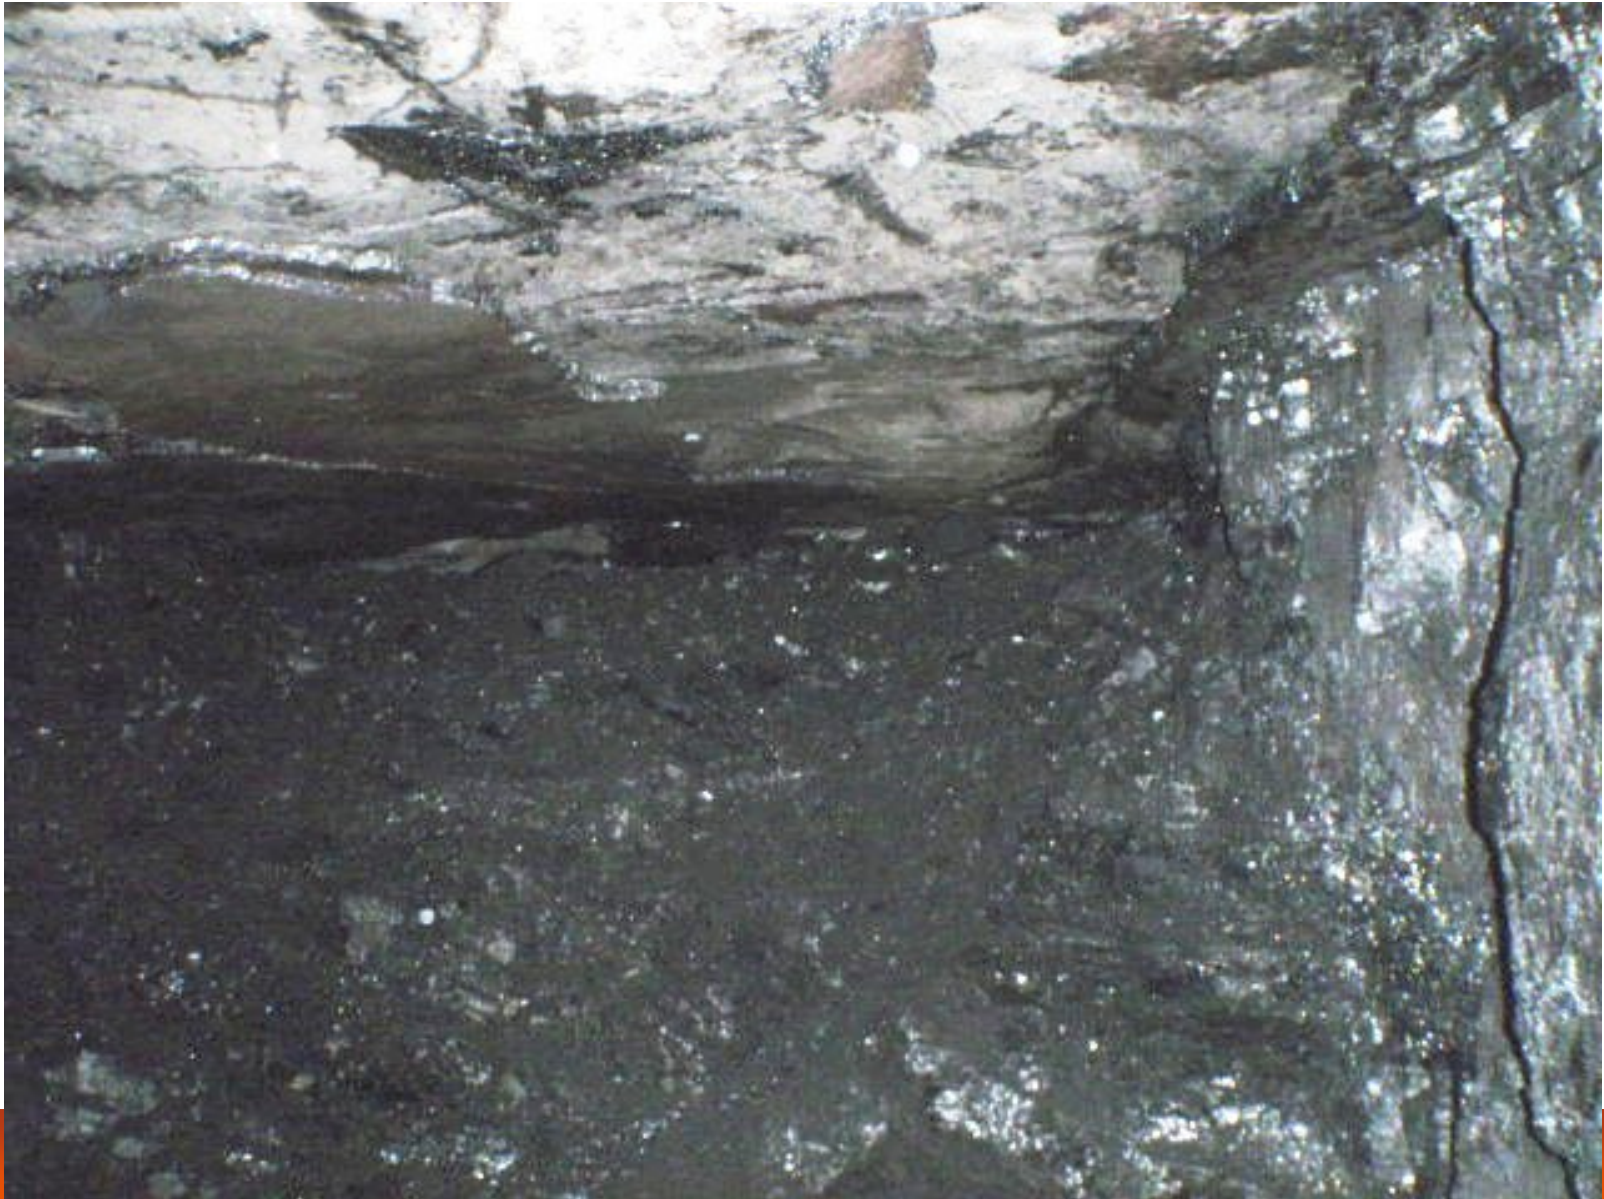
# Outburst Void RHS – Once coal loaded out

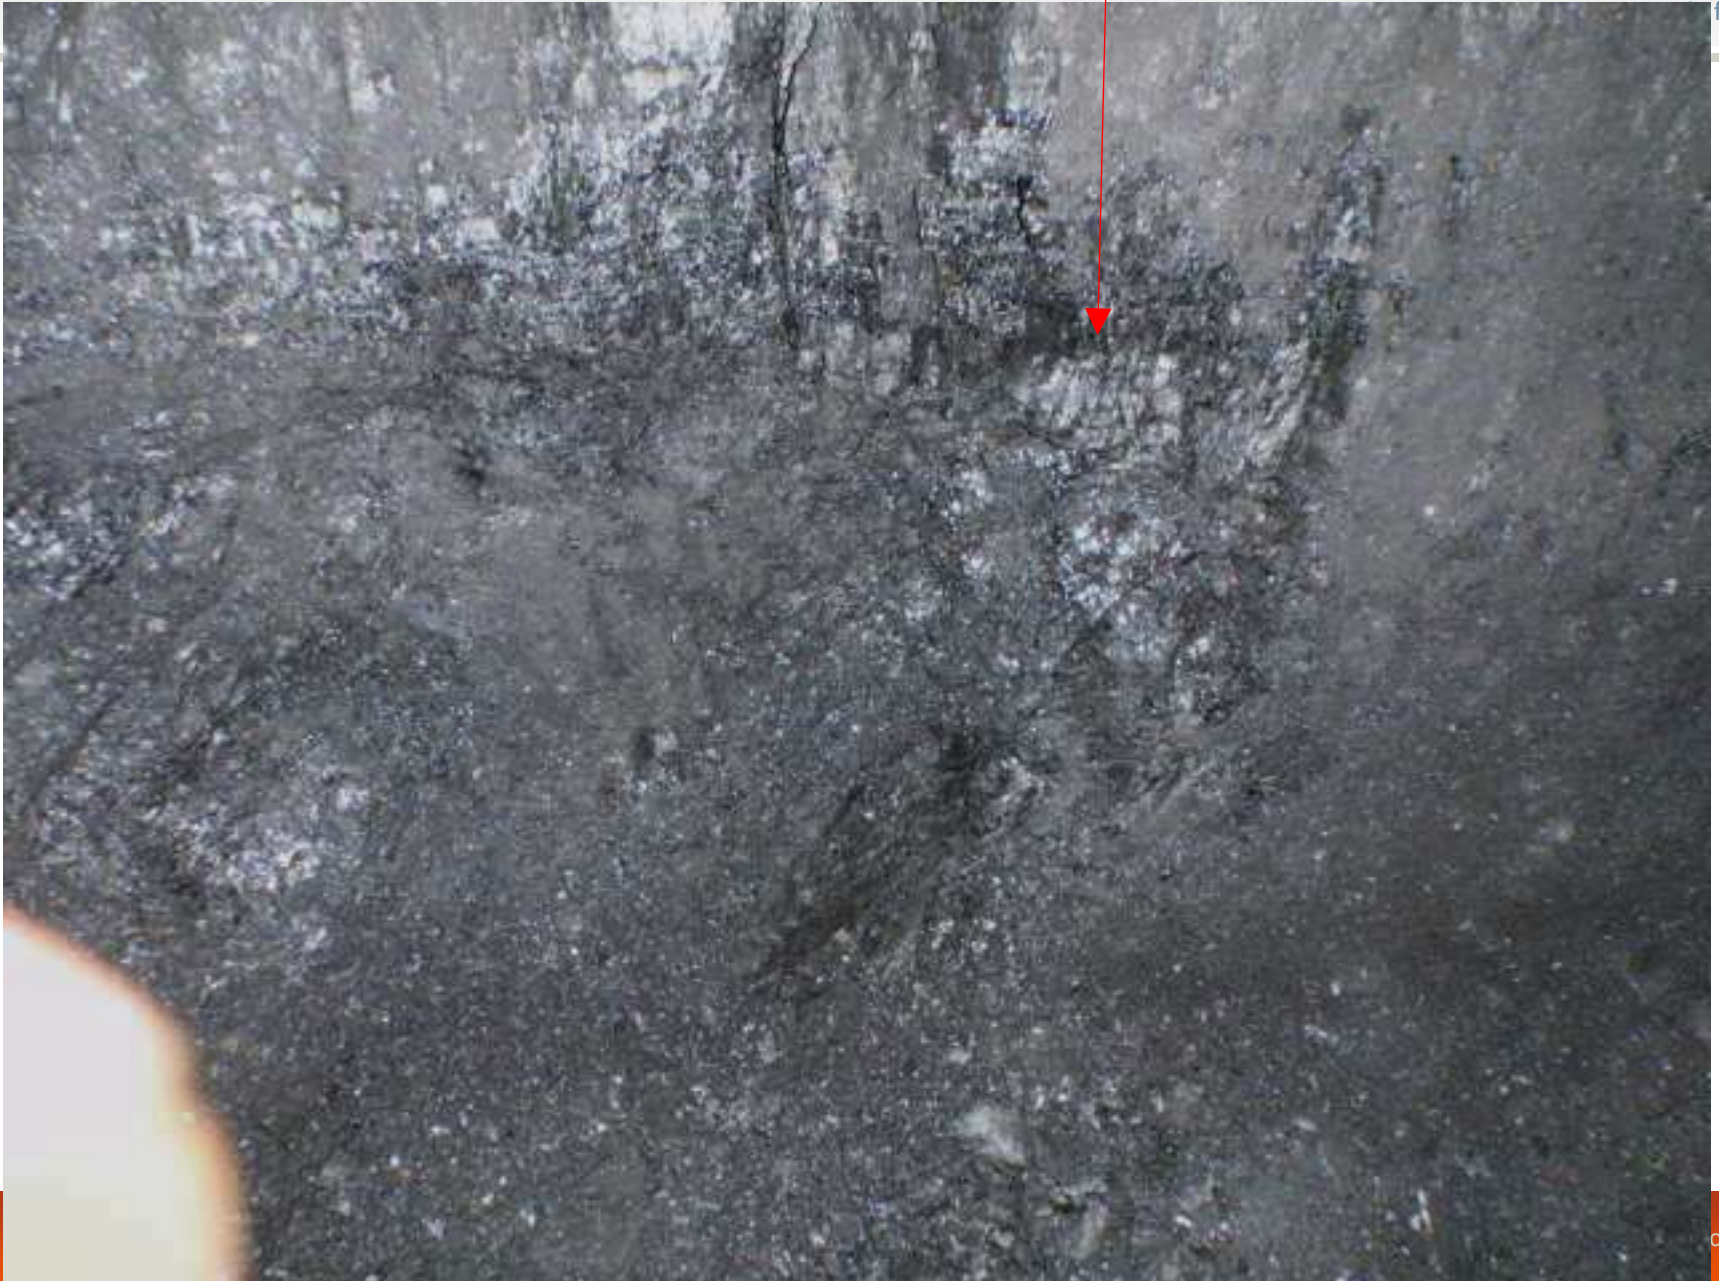
# Bottom part of outburst – Shiny Slickenslides
