# Appin Colliery

## MG703 Outburst Presentation

Gas and Outburst Seminar  
25<sup>th</sup> June 2009

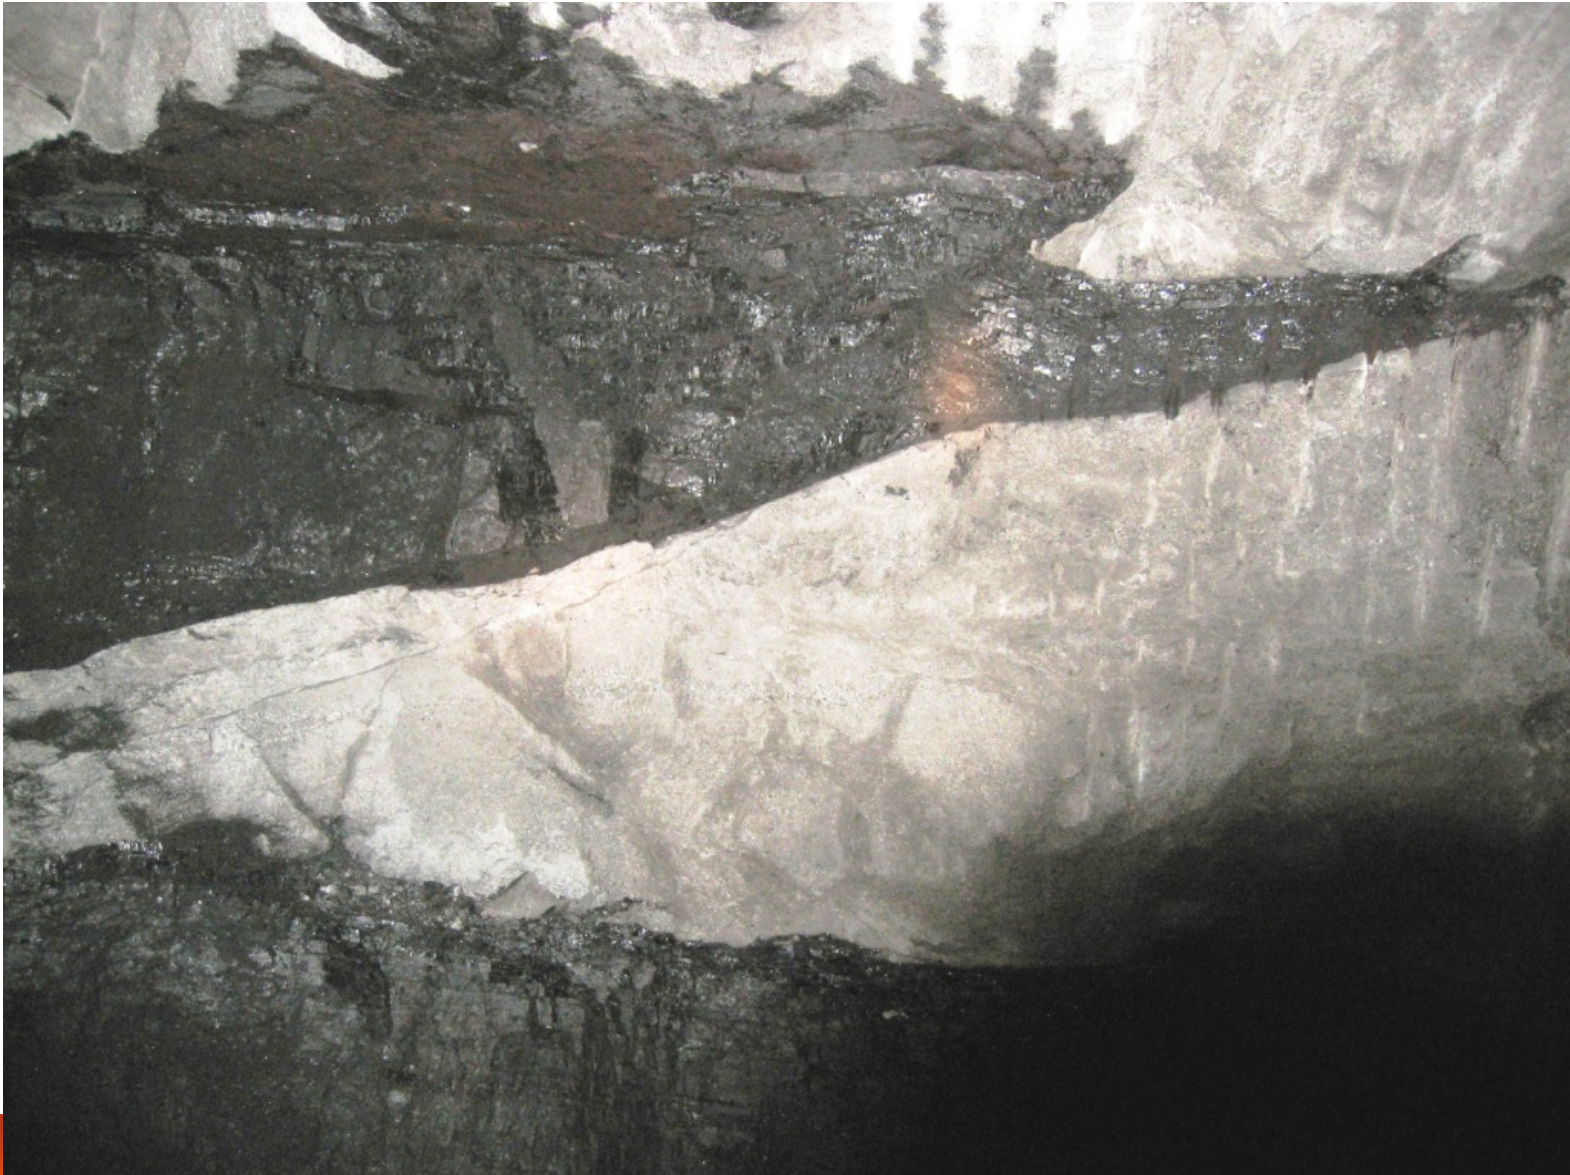
# Thrust Fault – Approx 0.5m vertical displacement.

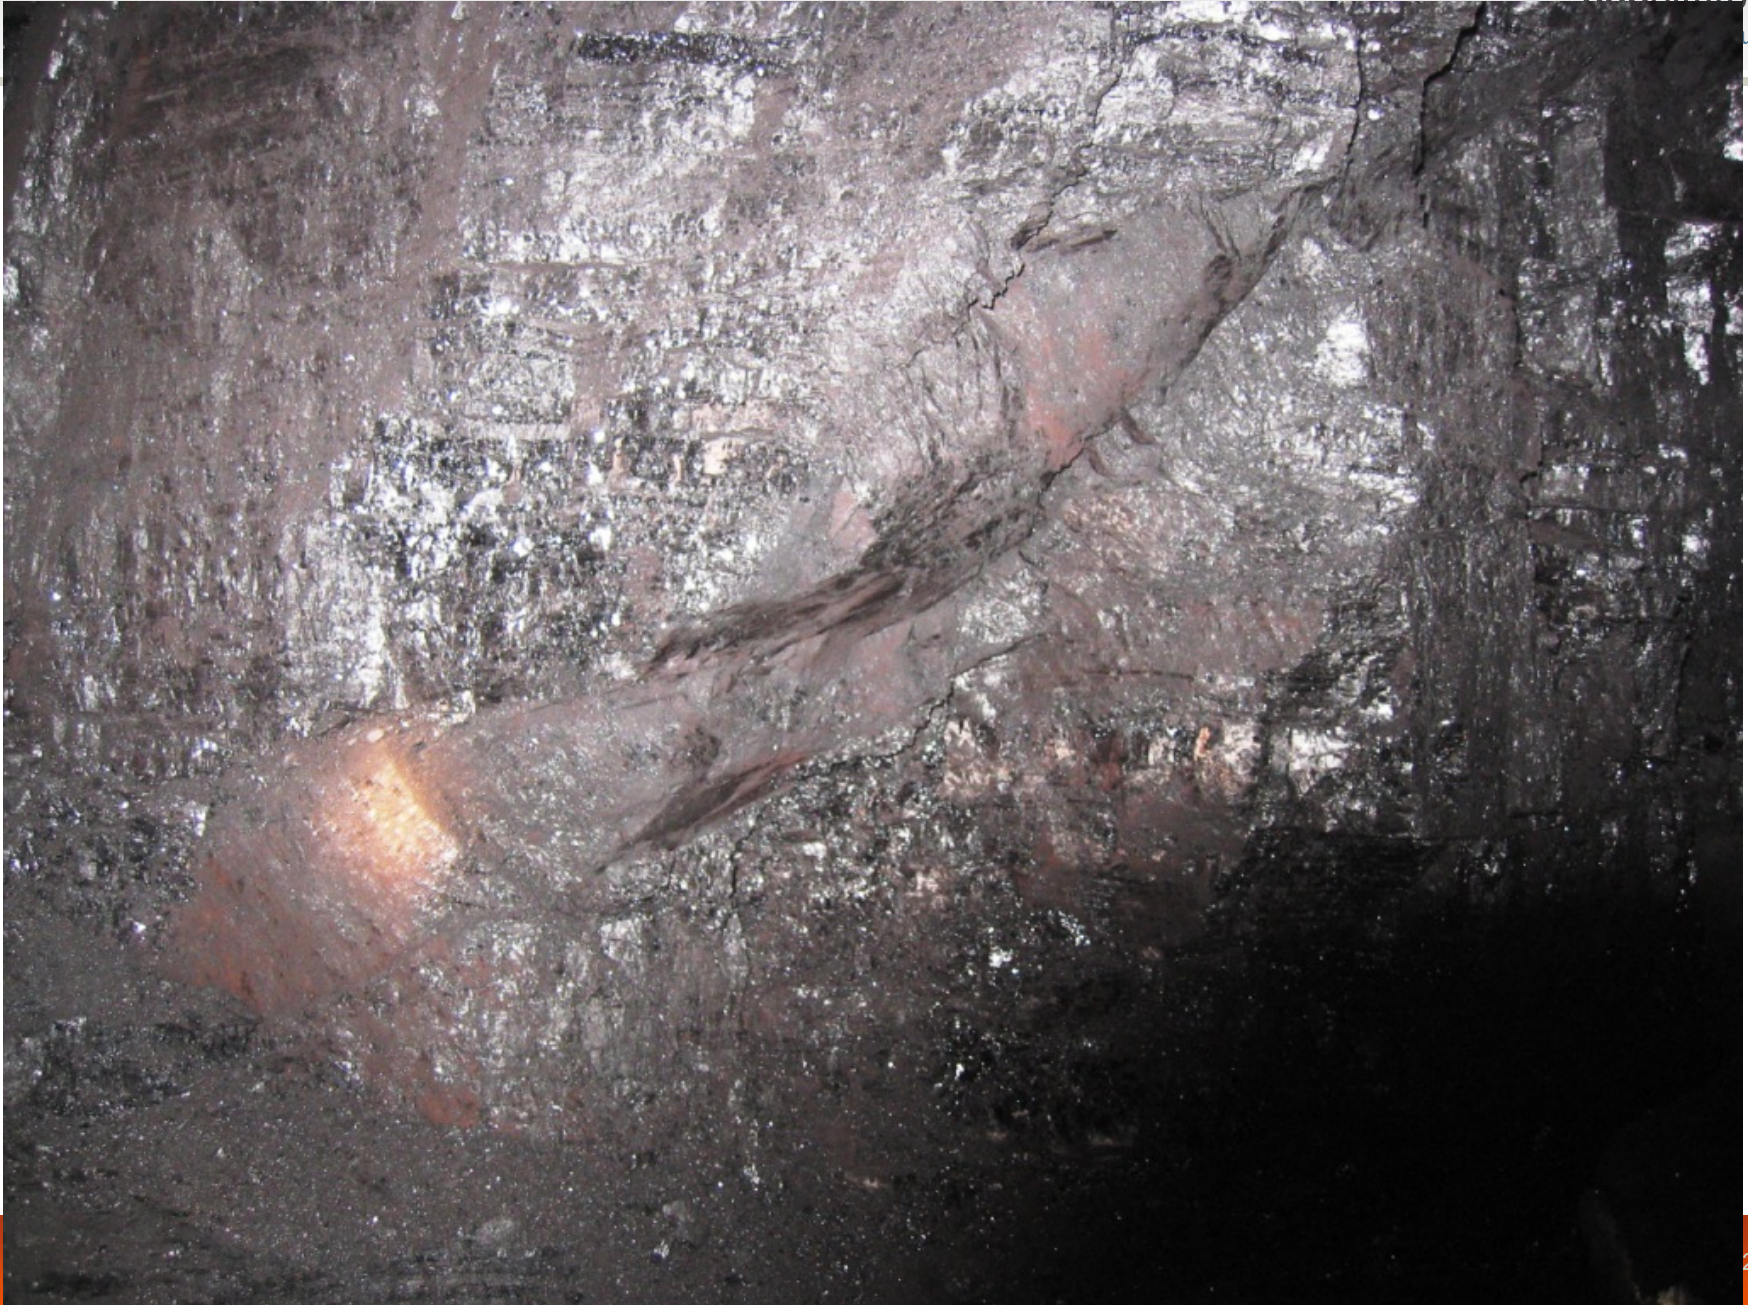
# Thrust Faults

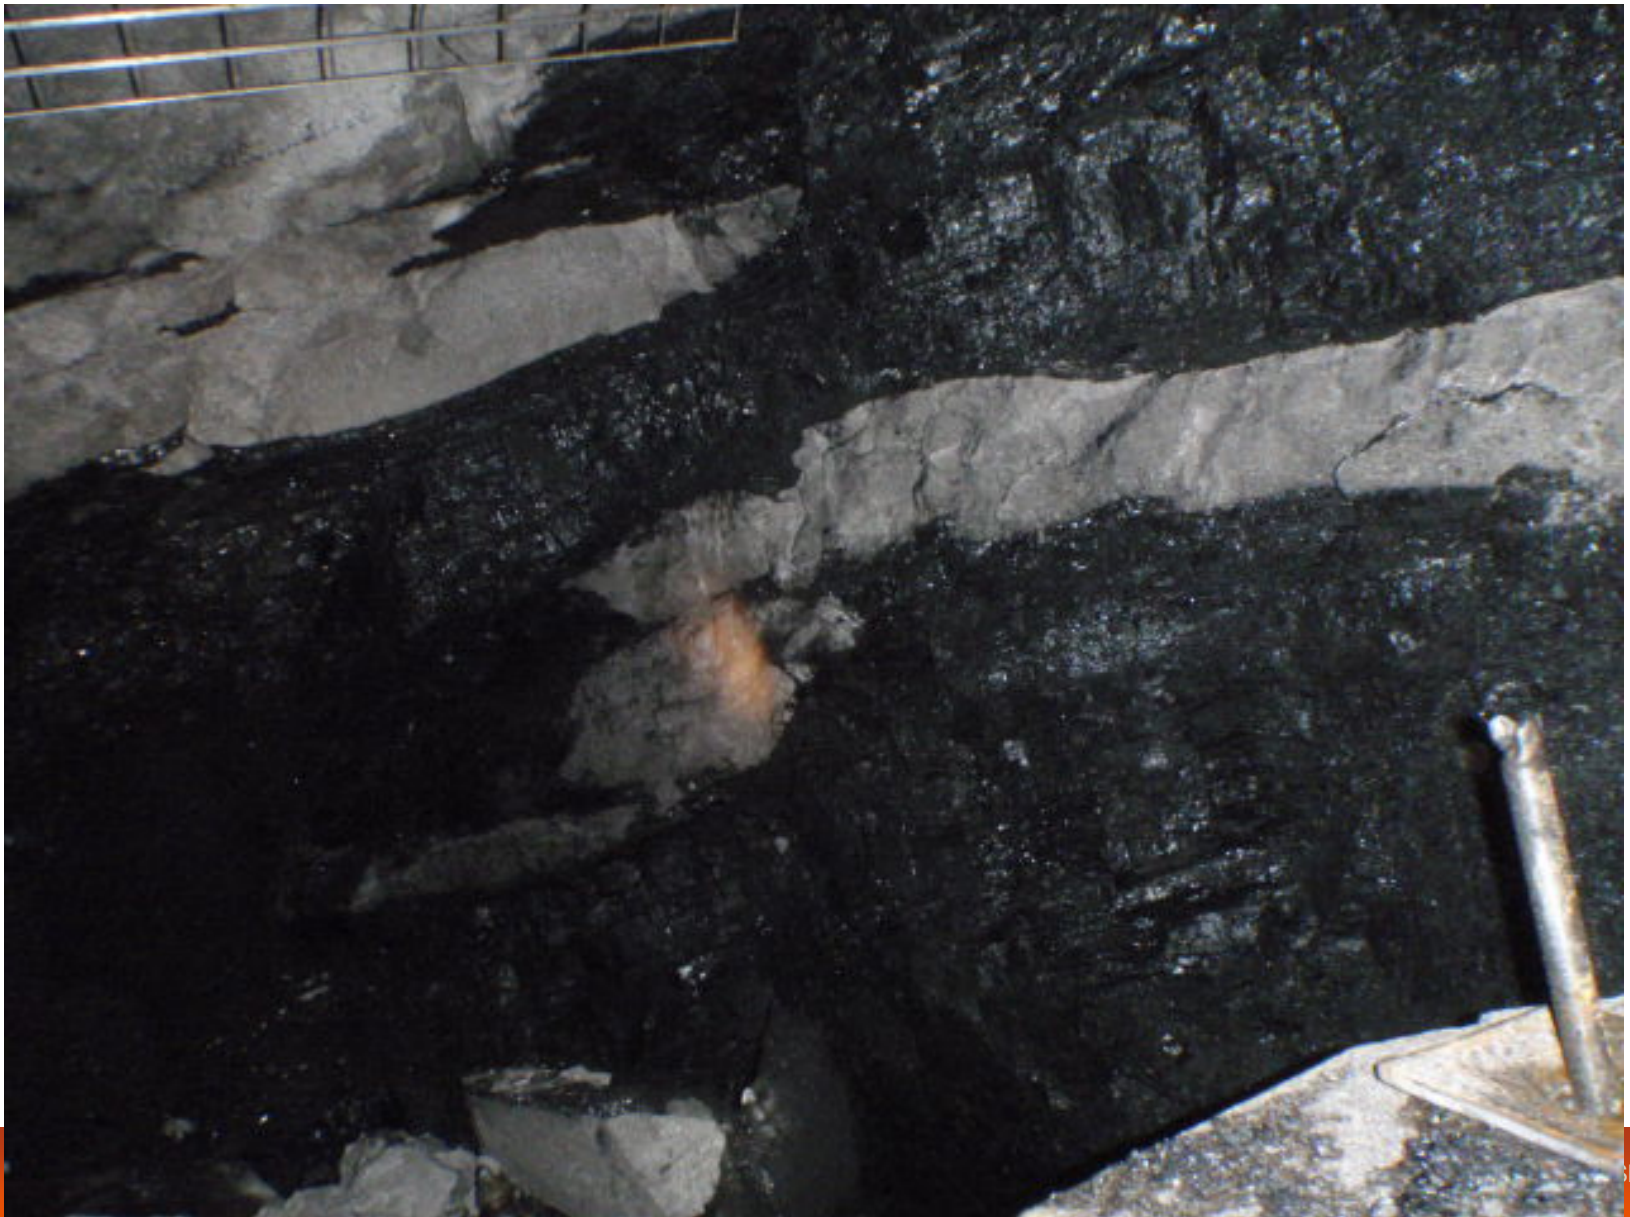
# Sandstone Floaters.
