Tahmoor Outburst Event March 2018

Event Summary

Tahmoor mine had a small Outburst, approximately 200m³ of CO₂ and less than 100m³ CH₄, that occurred in 912 Panel 20-21A on Sunday 11 March.

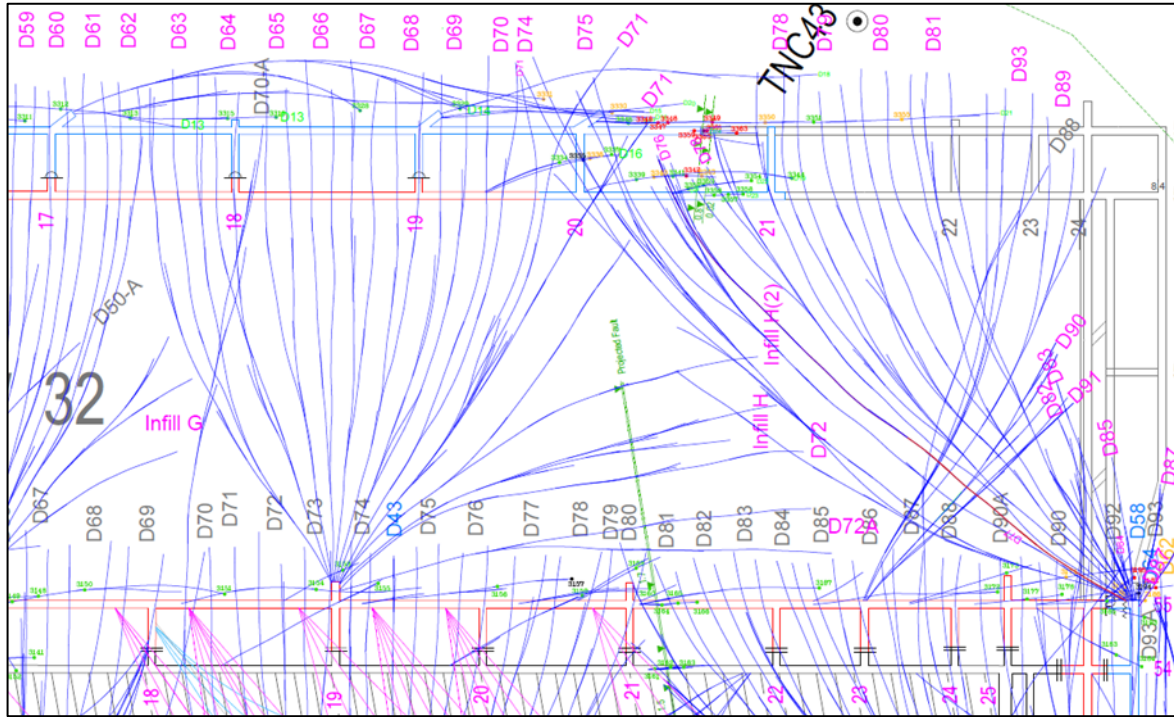
Background - Drilling

Attempts to drill and drain the area:

- Next plan was to drill flanking holes from the panel travel road once close enough
- A number of holes were attempted from 17c/t and 19c/t, which met similar difficult conditions in the same place I/B 20c/t. Again the drilled string was bogged for 24 hours from 17c/t

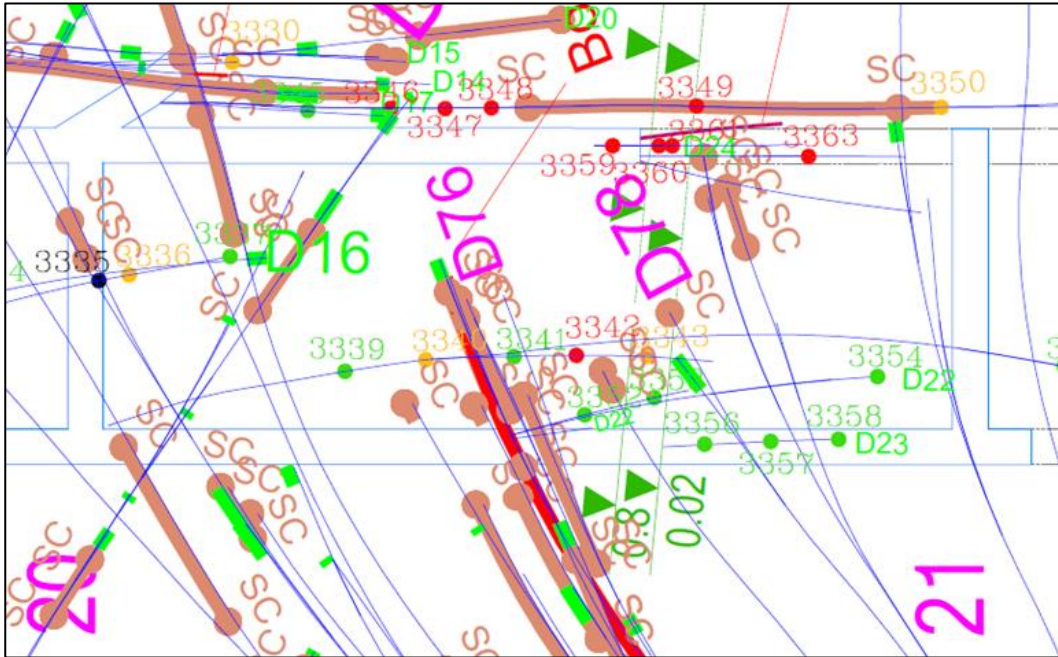
Background - Sampling

Sampling was conducted in both A and B hdgs in accordance with the Outburst Principal Mining Hazard Management Plan :

- Results in B hdg were below DTV indicating sufficient drainage to mine unrestricted
- B heading was at 129m at time of event
- This allowed an accurate projection of the fault for A hdg, and sampling was conducted according to the OPMHMP
- These samples were above DTV, and therefore remote mining, or grunching would be employed as it had countless times in the past
- Samples in the area around the event in A hdg ranged from 10.51m³/t to 15.38m³/t at a composition of approximately 65% CO₂ and 35% CH₄. The nearest sample to the location of the event was 10.88m³/t

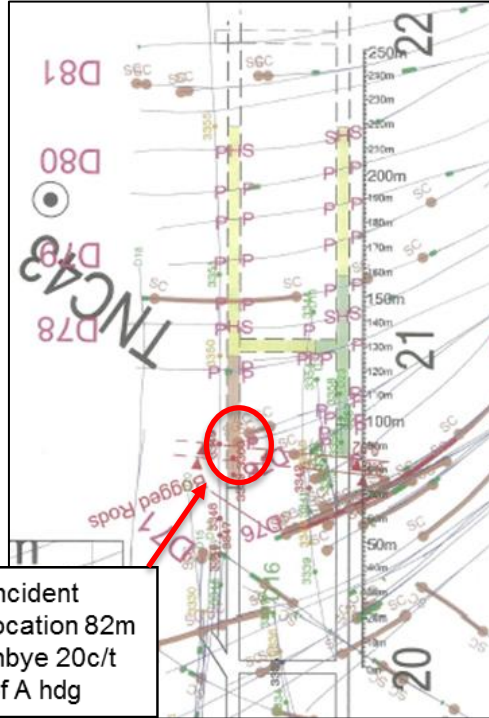
ATM and Grunching Process

- Grunching of the affected area commenced on 27 February 2018 at 32.6m inbye 20c/t.
- Approximately 14 rounds of grunching were completed between that date and Friday 9 March.
- The pattern used for grunching was consistent with that used successfully in the past utilising a 14 hole pattern to 3m depth.
- In the week preceding the event, the roof conditions in the roadway deteriorated to the point that production in A heading was halted to install secondary support to the face.

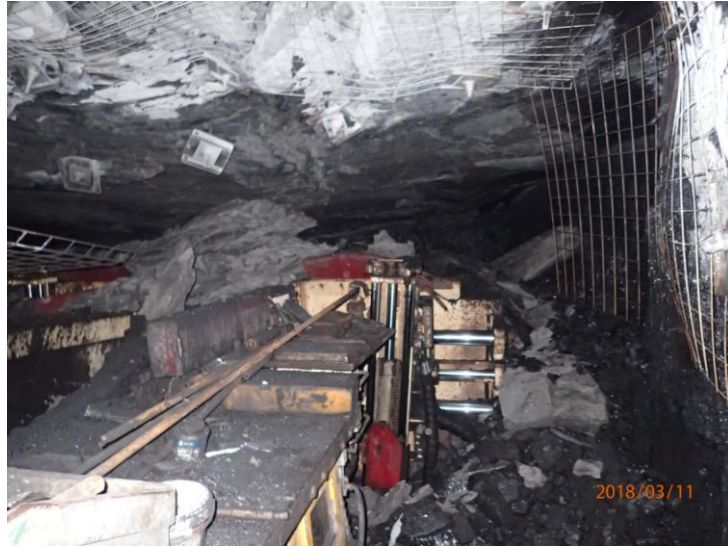
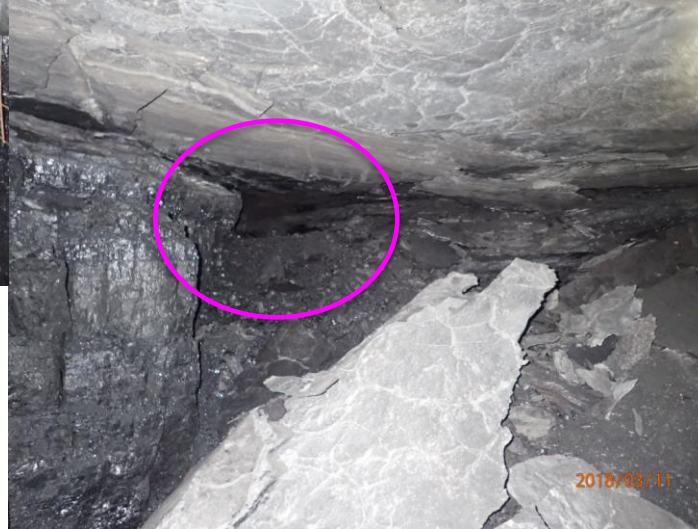
The event

Upon inspection of the face there was evidence of

- A small conical cavity in the top left corner of the face, including fine coal had slumped out of the cavity.
- The first signs of the same structure projected across from B Hdg.
- Coal from the mid to RHS of the face having bumped marginally forward whilst remaining mostly intact.

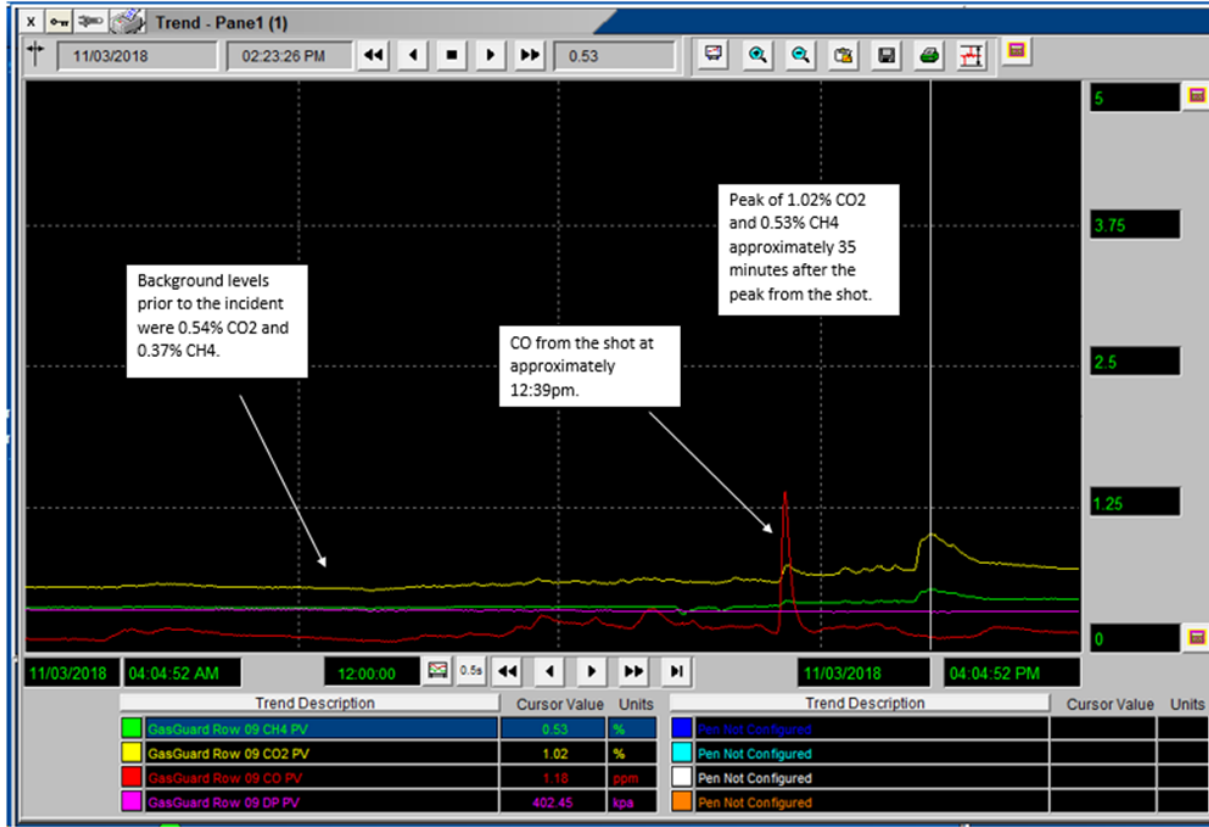
The event

- Monitoring was also in place at the outbye end of the panel return, the peak readings at this point were 1.02% CO2 and 0.53% CH4.
- In approx. 30m3/s of air this equates to a peak flow of 300 l/s CO2, or over the 45 minute period to return to background levels a total of 200m3 CO2 and 65m3 CH4

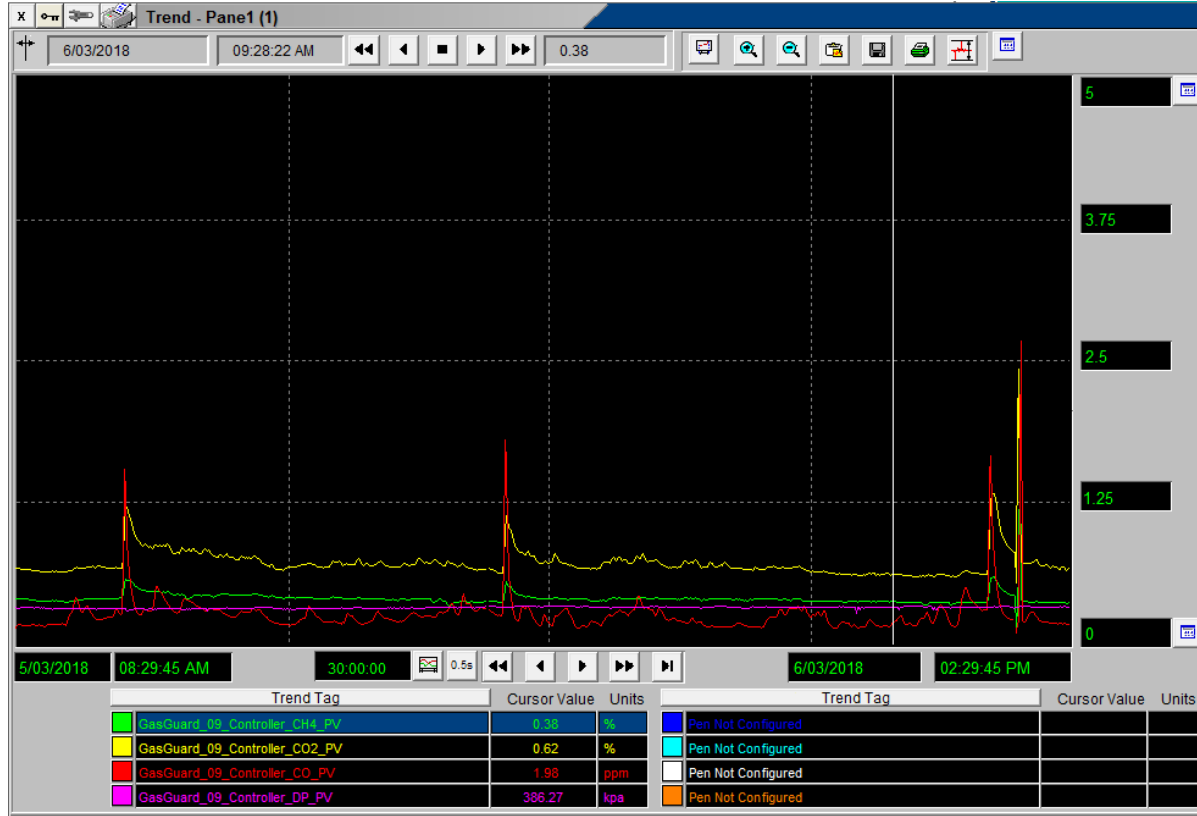
The event

- It can be seen that in previous shots the release of gas has coincided with the shot

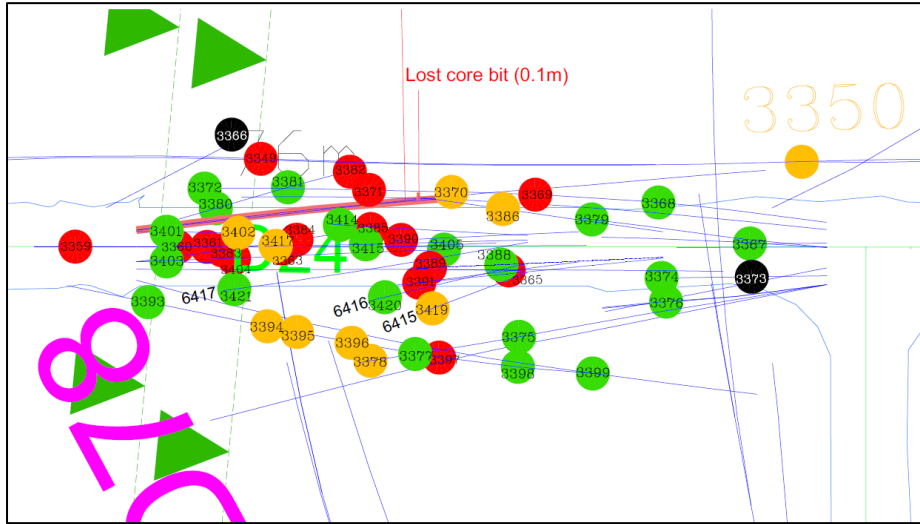
Mining post event

- At this time there was 45m of coal to mine
- A series of holes were drilled into the 45m zone from O/B face as well as inbye the zone (B hdg and the C/T were driven based on unrestricted core sample results)
- Unrestricted cores obtained to mine I/B face back O/B.
- Applied a 5m standoff from pass cores – were not 100% certain of fault location at that point in time.
- Applied “worst” sampling across the cross section of the face, due to 2m sampling from borehole rule

A Prohibition Notice was served on Tahmoor subsequent to the event. It stated that the area inbye the event location was not to be mined until a satisfactory method of mining was determined.

Tahmoor responded to the Notice stating that the area would not be mined until the gas content was reduced below the existing thresholds for unrestricted or restricted mining. Remote mining would not be utilised until a full assessment of the process was conducted. This was considered acceptable to the Regulator and the Prohibition Notice was lifted.

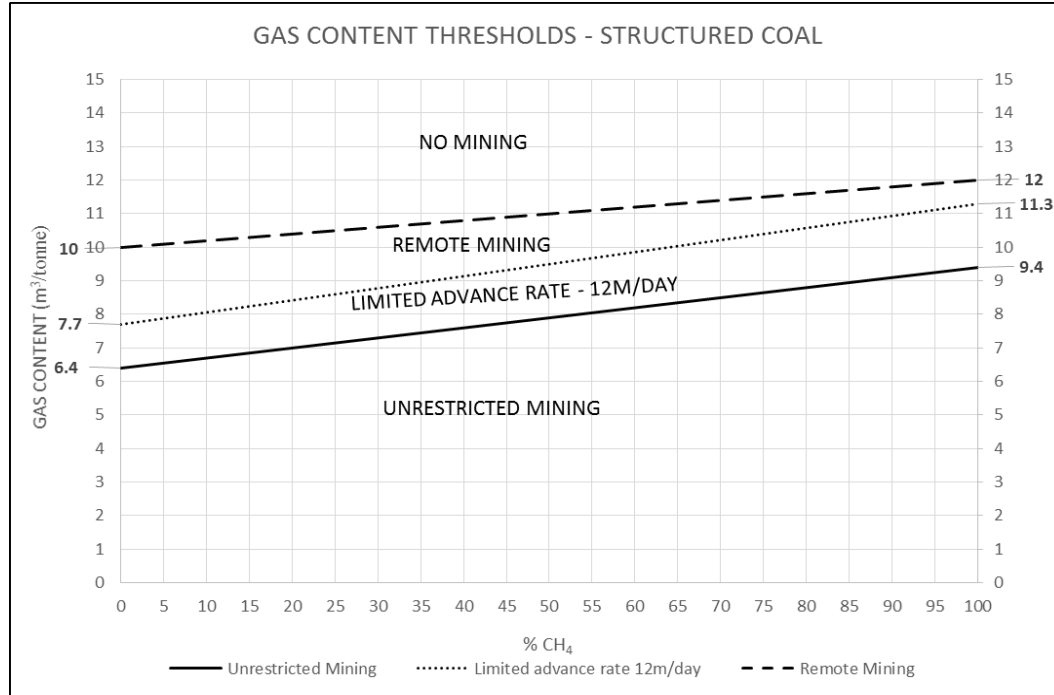
Amendments to OPHMP

Upper limit for Structured coal:

- By limiting the gas content, it reduces the amount of gas available to be released and the level of energy involved.
- The recent event occurred in an area that had been sampled to be 10.88m³/t (35/65, CH₄/CO₂).
- Based on a single "fail case" data point, an upper limit for structured remote mining of 10m³/t in 100% CO₂ to 12m³/t in 100% CH₄ should be applied, approximately corresponding with the gas content in the area of the event.

4. Implement an upper limit of 10m³/t in 100% CO₂ to 12m³/t in 100% CH₄ in structured coal above which no mining will occur and include in the Outburst Principal Mining Hazard Management Plan. Also included an upper limit of 18m³/t in unstructured coal which would initiate a review of mining conditions and methodology. (Reference to no mining limit)

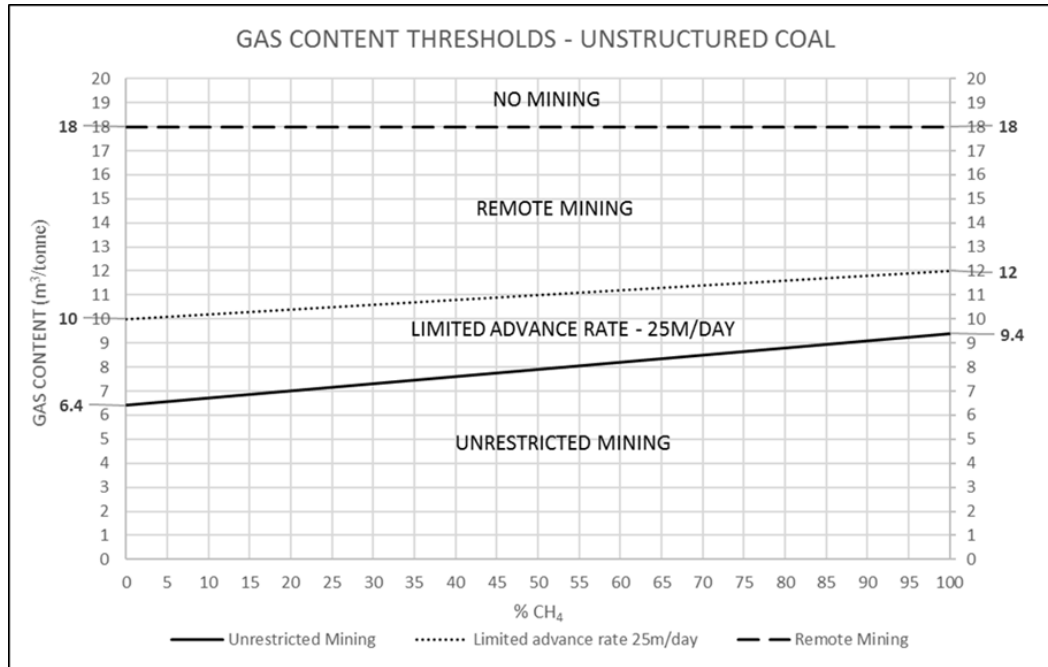
Amendments to OPHMP

Upper limit for Unstructured coal:

- Tahmoor has an extensive history of remote mining through unstructured high gas content areas without initiating an outburst.
- Therefore, for unstructured coal, the group determined it to be acceptable that an upper limit of 18m³/t (regardless of composition) should trigger a review of mining conditions/methodology based on that gas content being considered the extent of the "normal" gas content range observed in Tahmoor North.
