# **Overview of Mine**

#### **Pike River Mine**

# The incident Nov 2010

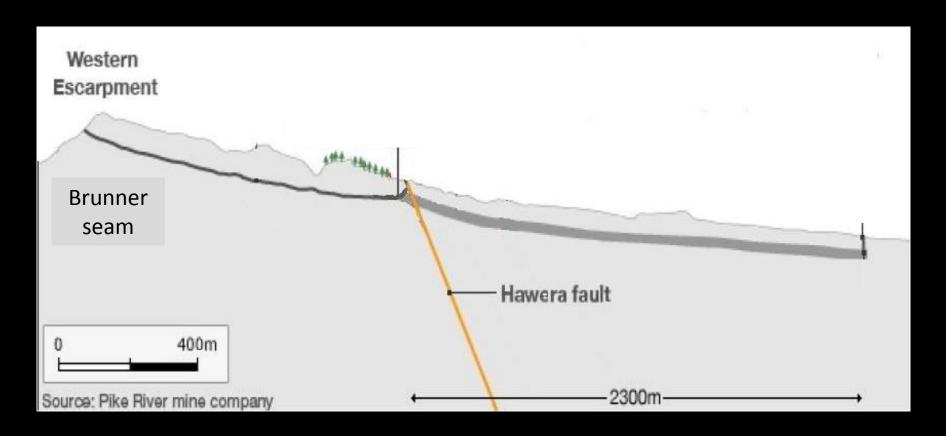
- Mine accessed by 2.3km stone drift (1 in 11 grade)
- Ventilated by single upcast shaft
- Main mine fan at base of shaft 125m³/s

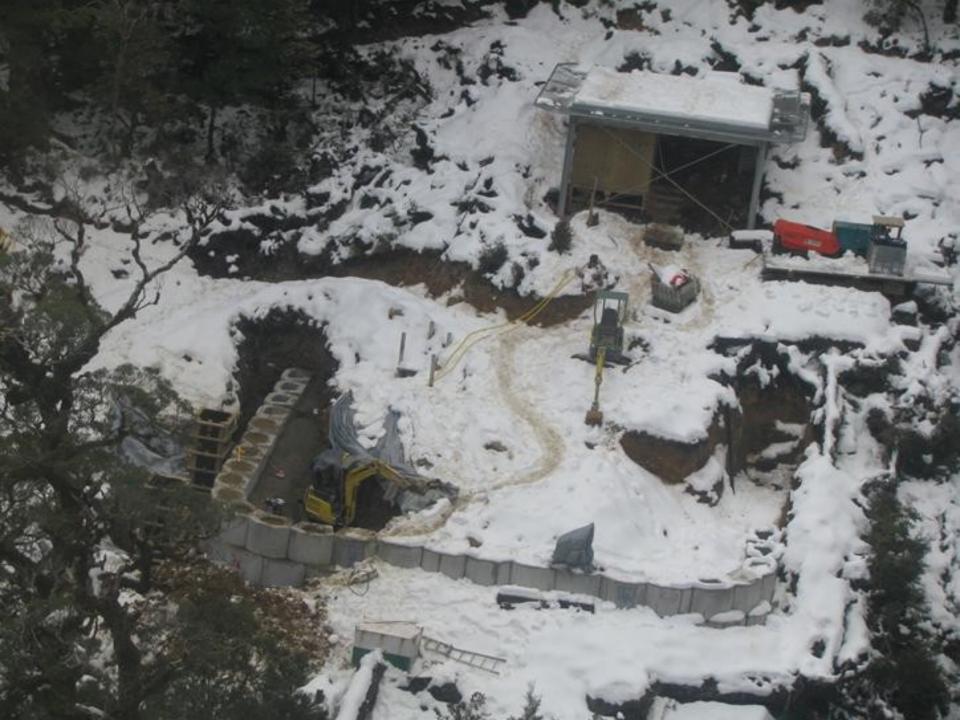
#### **Main Vent shaft**

- Rib failure at base of shaft
- 30m shaft blocked
- Shaft plugged and bypass raise driven (2.8 x 2.8)

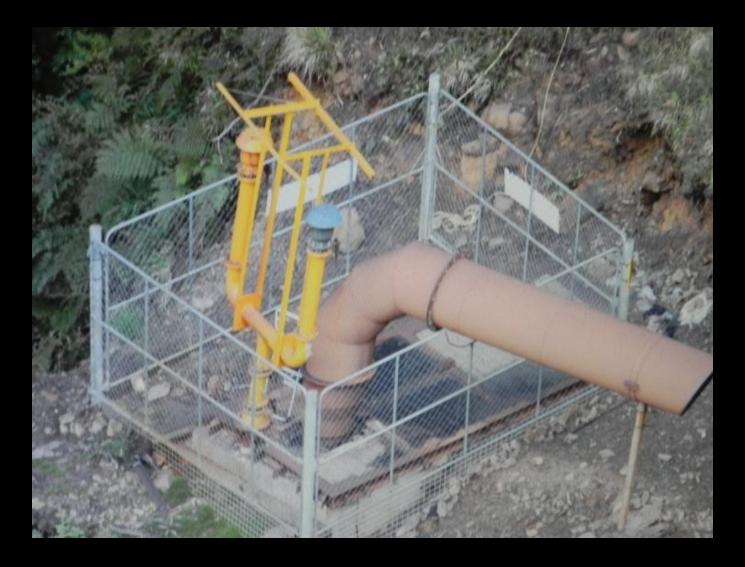
## **Slim line Vent shaft**

- 600 mm diameter
- 100 mm Gas drainage riser (approx 150 200l/sec)

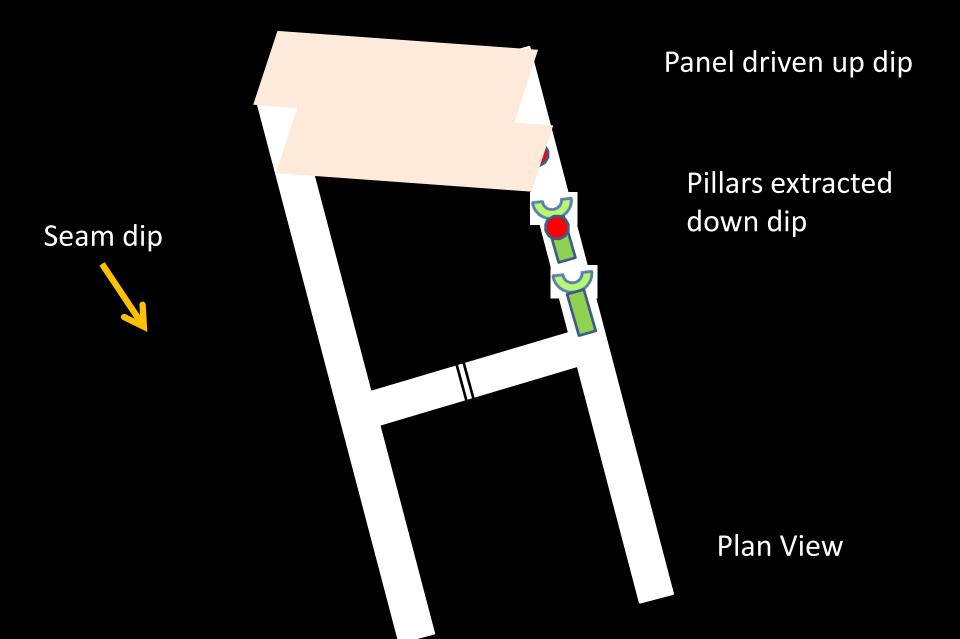
Hydro pillar extraction – Pillar extracted between Intake and return

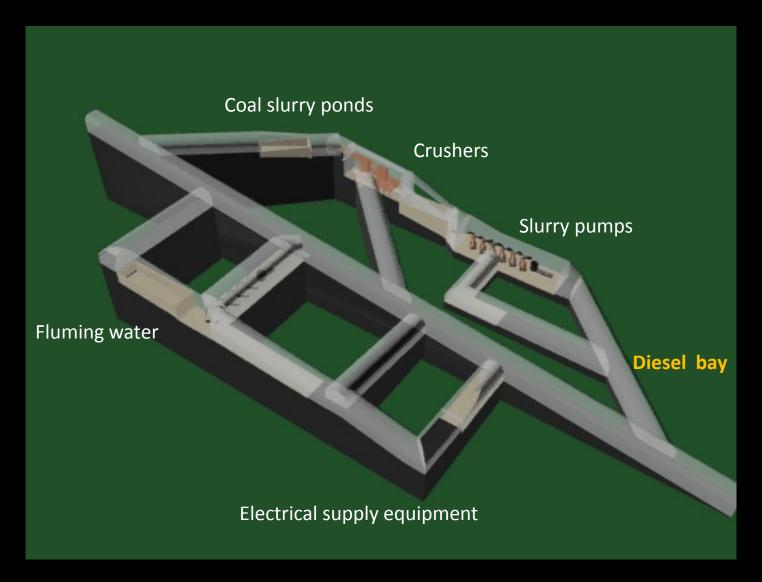
## Pit Bottom in Stone – Slurry Sumps

Coal crushed to < 35mm - Slurry 35% – 40 % coal to water

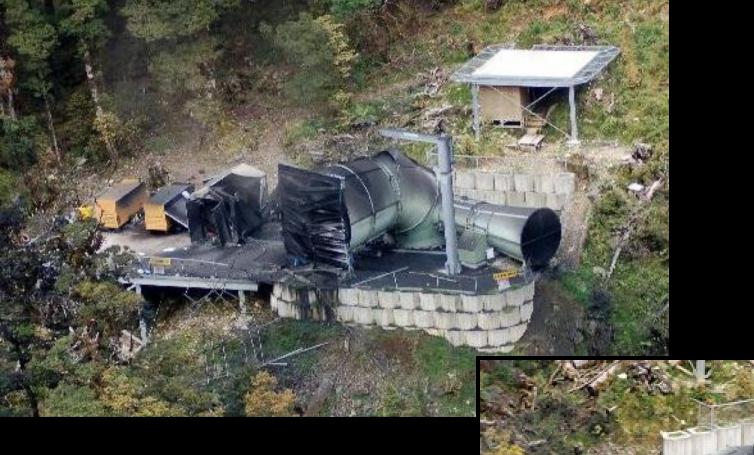
5.10pm Manager inspects ventilation shaft by air.

Observes light smoke & "blast" damage

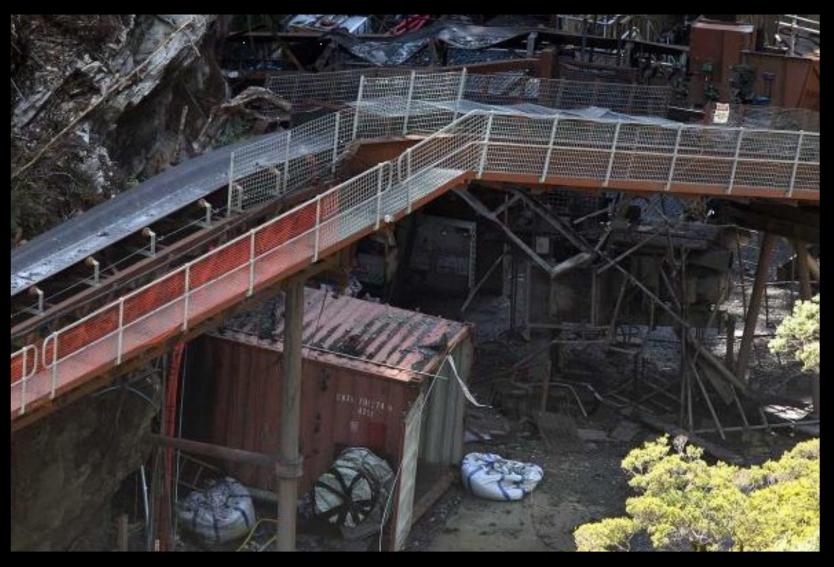
Portal sealing – sea container surrounded by void filling foam
