Outburst Compliance Challenges Oakley #1 Mine MG33A_21-24c/t

Gas and Coal Outburst
Seminar, Wollongong,
November 2015

Oaky Creek Coal

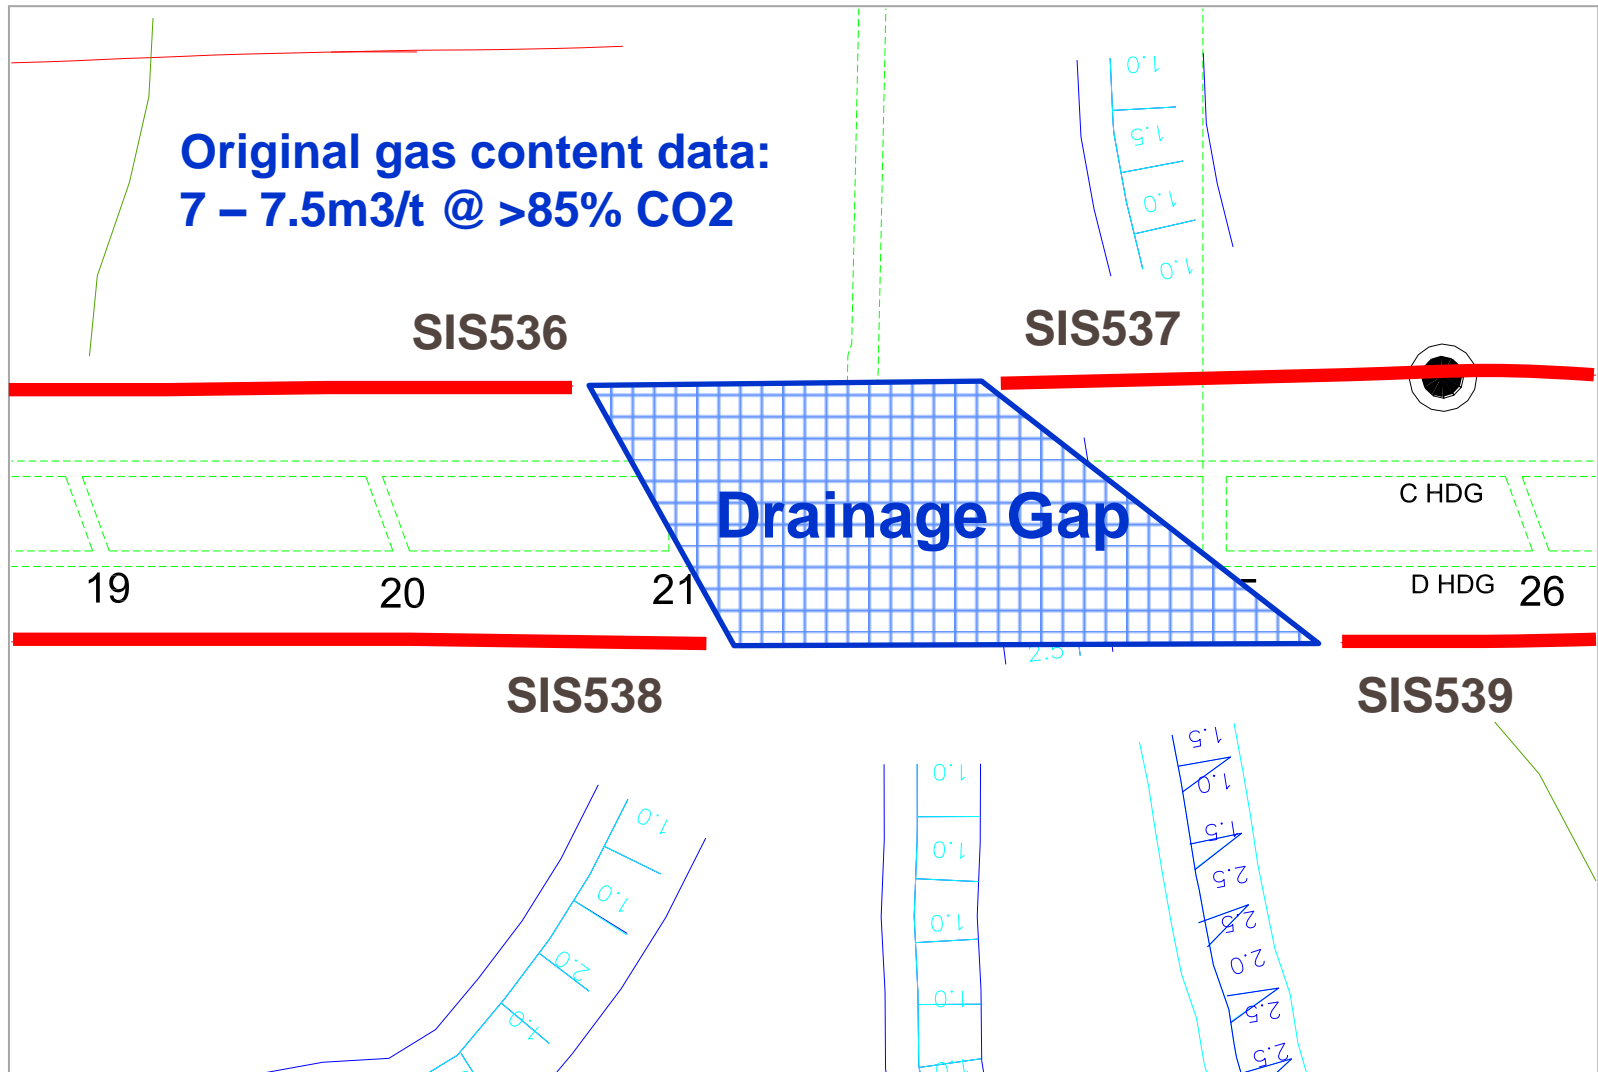
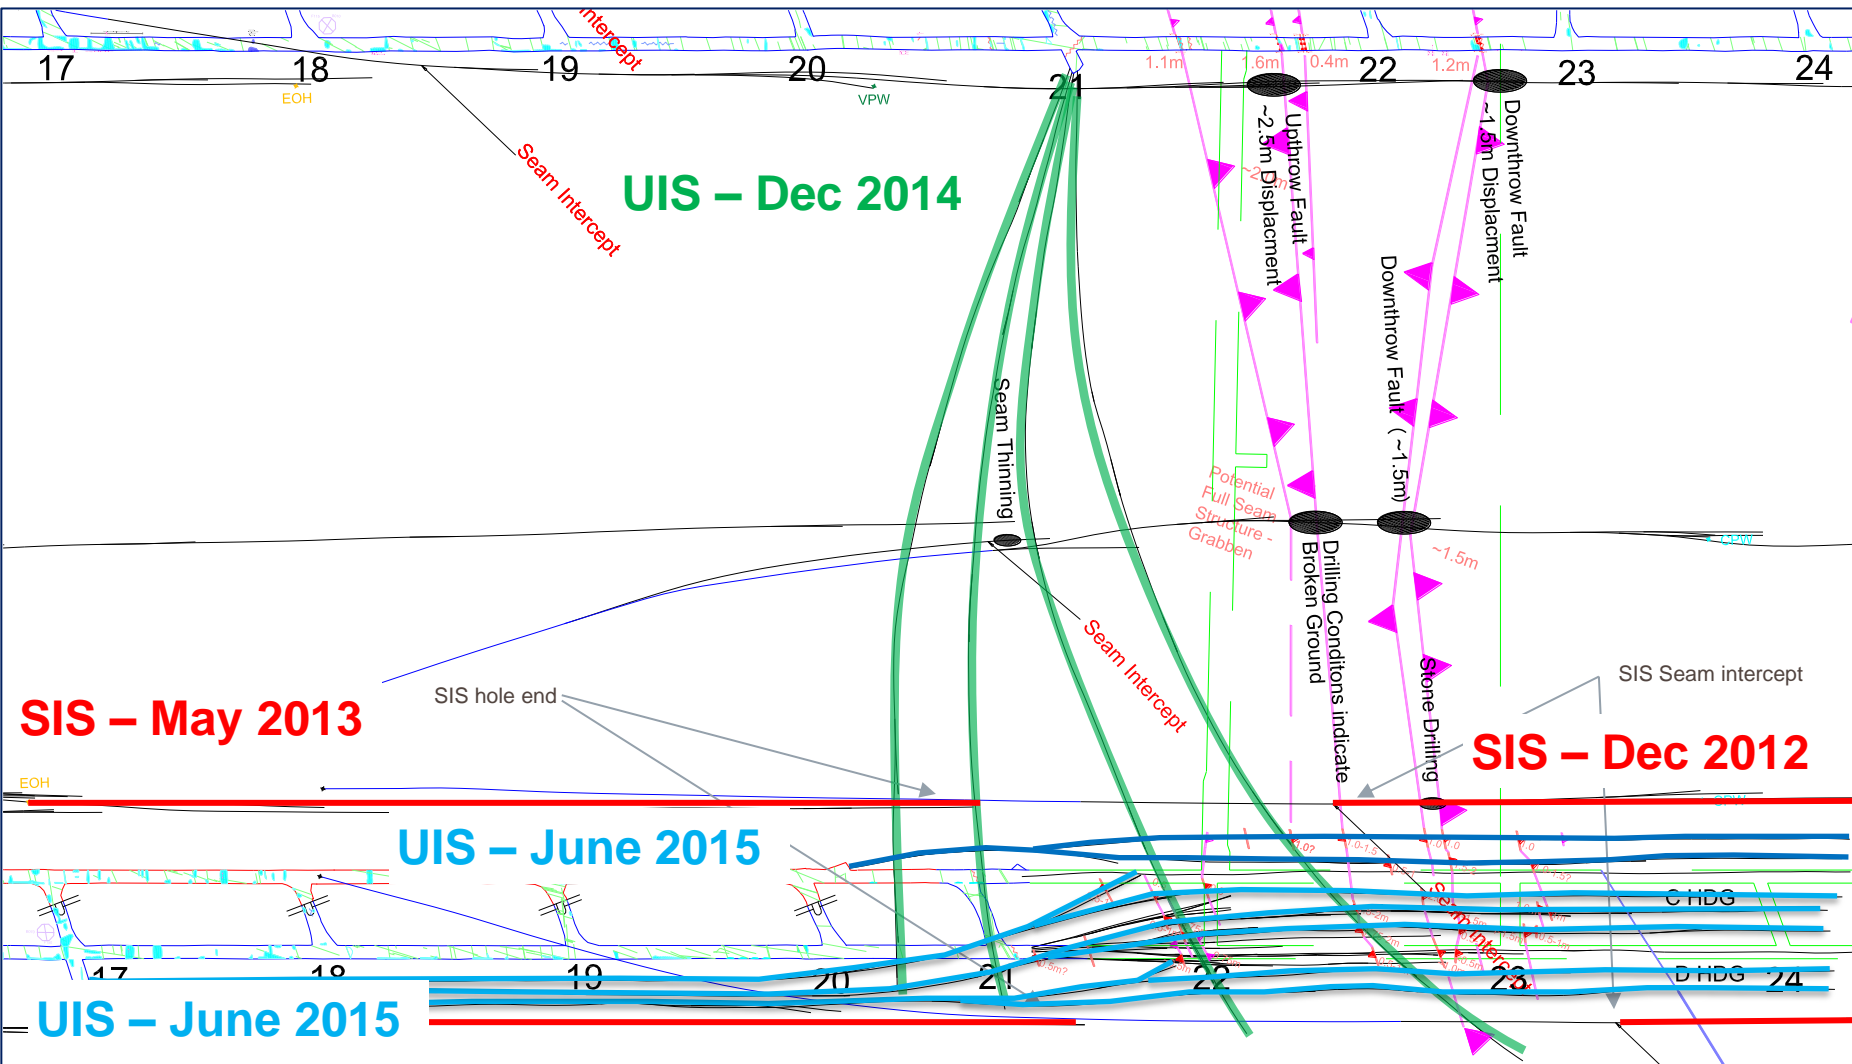
History: Situation in late 2012 showing 3D seismic predicted structures, and in-seam portions of SIS drilling

- **Long term SIS drainage in place in late 2012 to mid 2013.**
- **Design flaws identified in August 2013.**
- **Infill UIS cross-block pattern drilled from MG33 December 2014.**
- **Infill UIS failed to drain adequately.**
 - Down-dip to target zone through existing drained (de-pressurised) areas.
 - Low desorption pressure CO2 struggled to self de-water.
 - Some blockage issues around fault intersections.
- **Became obvious that more drainage was required**
 - More cross-block holes were rejected.
 - Elected to drill a tight spaced parallel pattern ahead of development.
- **Slow drainage still!**
- **Intersections compromised some boreholes soon after drilling**

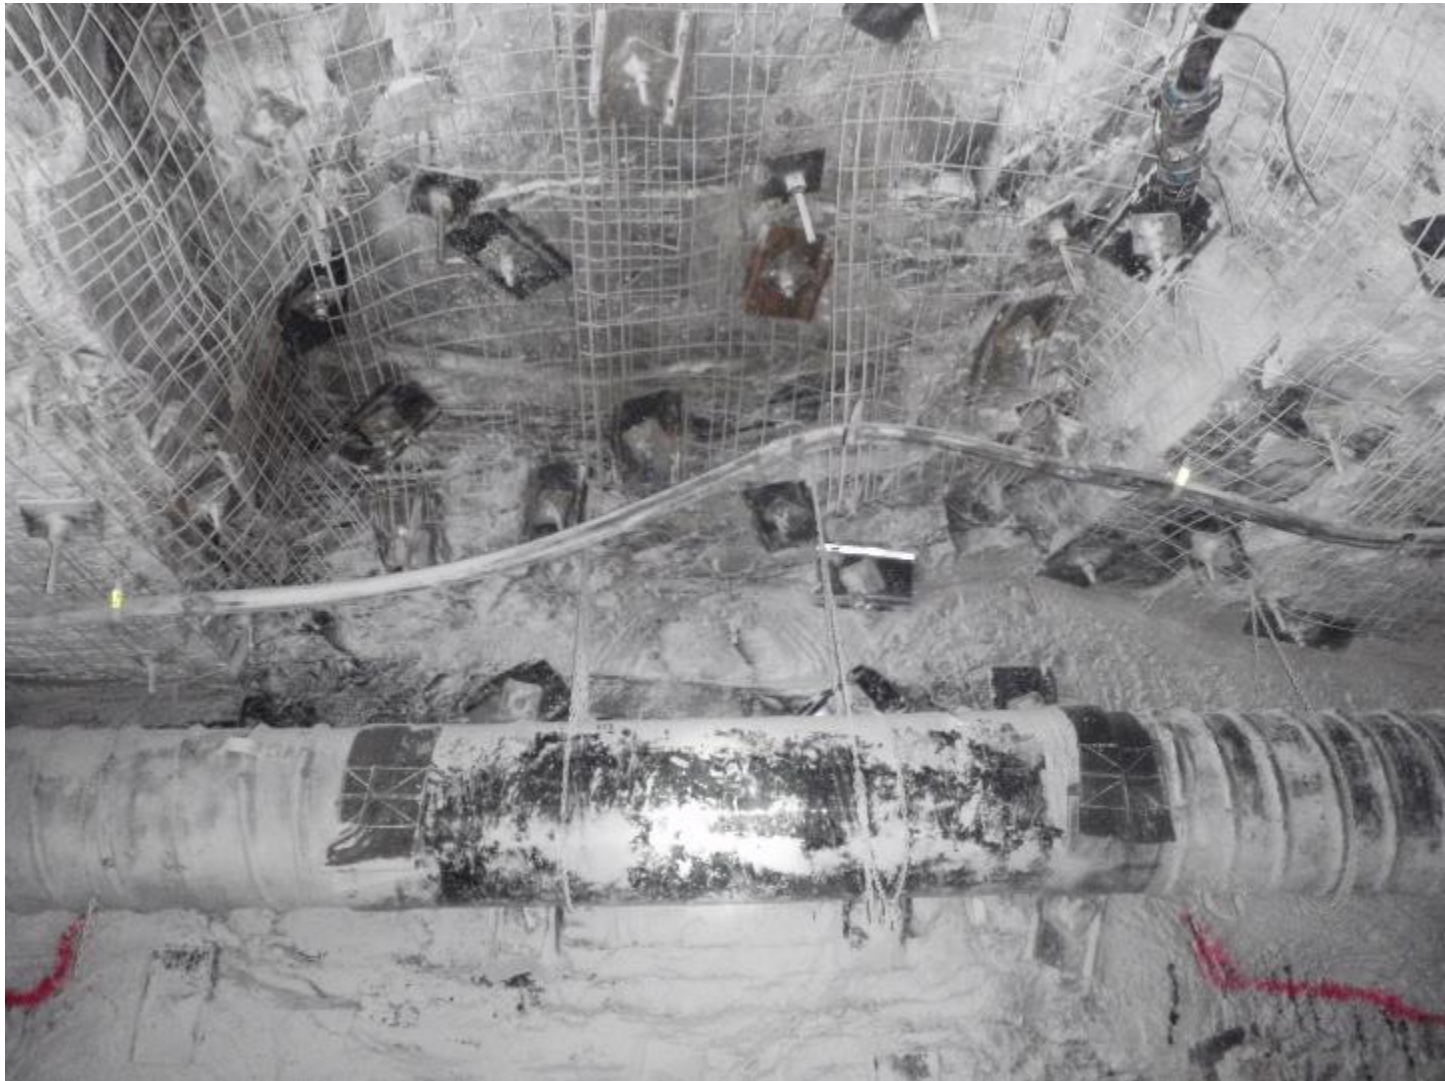
D22A C/T +49m Horst Pillar Rib

- SIS design had some weaknesses which the excellent drainage time (>2 years) could not compensate for.
- Down-dip cross-block UIS pattern struggled to de-water the seam.
- Geological mapping revealed less jointing, no change in cleat angles or frequency.
- No real indications that joints or cleats were infilled with minerals
